**SOLANO COLLEGE –
BUILDING 1200
DUE DILIGENCE REPORT FINAL
(MECHANICAL, ELECTRICAL,
PLUMBING, FIRE PROTECTION)**

INTERFACE ENGINEERING INC.

JULY 09, 2008

2008-0312

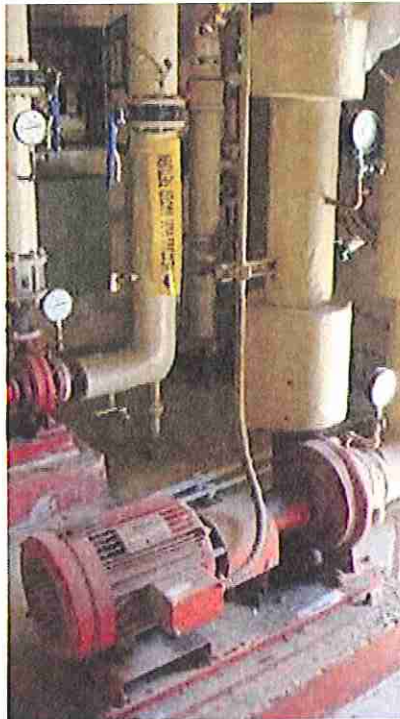
1. The existing system is a 6" automatic sprinkler system with the main coming in from the East side of the building. The existing sprinkler riser is not provided with a drain to the exterior of the building. The sprinkler riser is located inside the Mechanical room, tucked in the corner behind the hydronic pipe risers and pumps. It is in. See Figure F1. We could not identify additional risers within the building with the facility engineer.

Figure F1: Fire Riser Tucked in Corner

1. Demolish the existing original 6" fire sprinkler service and install a new fire sprinkler main. We anticipate that the fire sprinkler system will also be required to be 6".
2. Install all new automatic fire sprinkler system throughout the building including office spaces, mechanical rooms, classrooms, storage spaces, practice rooms, restroom and corridor. The automatic fire sprinkler system will be required to be in compliance with local Codes, local Fire Marshall requirements, the DSA, and NFPA 13.
3. New sprinkler riser shall be located to a more accessible location.
4. Provide sprinkler riser with a drain to the exterior of the building.
5. Install backflow preventer assembly and post indicator valve.
6. Extend the new automatic fire sprinkler system into the new Building Fire Alarm system.
7. Install a new smoke vent above the stage.

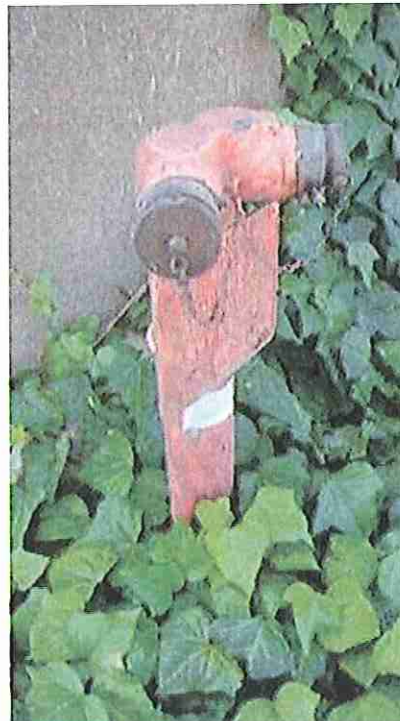
4. There is a Fire Department connection on the Northeast side of the building. See figure F2.
5. There are (4) Fire Hose Cabinets in the Theater. They have expired and have not been certified or tested recently. See Figure F3.

Figure F2: Fire Department Connection

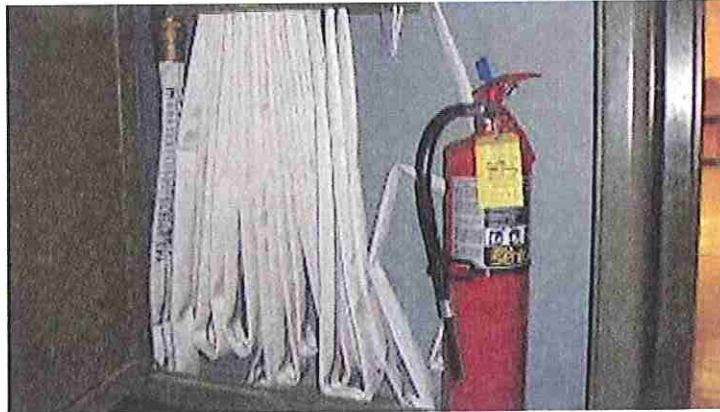
Figure F3: Fire Hose Cabinet

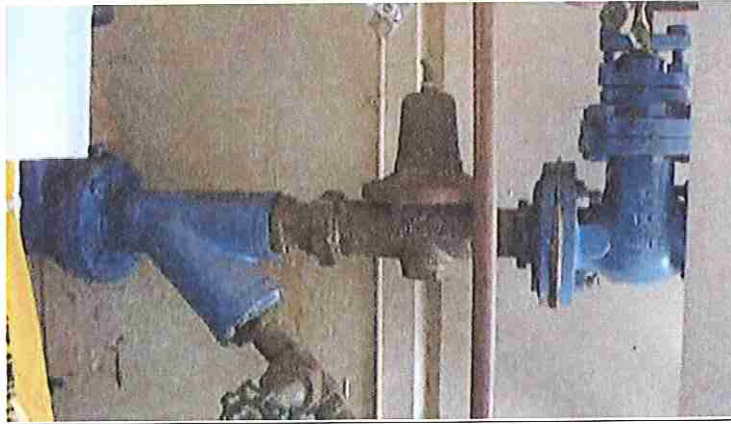
3. Domestic Cold Water: The building is serviced by a 3" domestic cold water main which entered the Mechanical room from the East side of the building. Isolation valves and backflow assembly valve were also provided. See figure P1. The cold water pipe is then split in two branches with its own isolation valve, one serving the Theater side and the other servicing the Classroom side. These valves were installed with the piping directly above the electric transformer and switch board which is an NEC code violation and a fire hazard. See figure P2. In discussions with the on-site engineer, there appears to be adequate pressure throughout the domestic water system.

Figure P1: Domestic cold water assembly

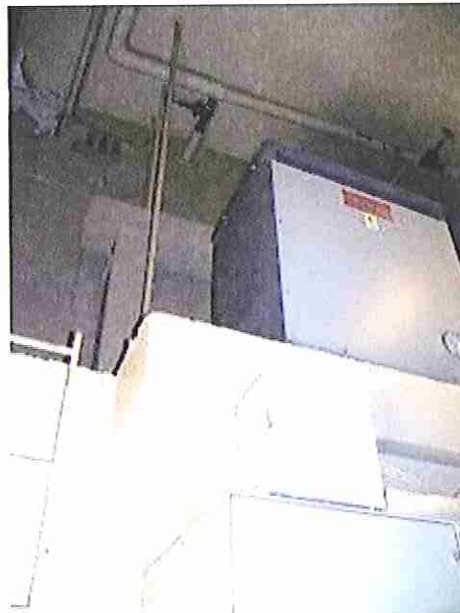
Figure P2: Domestic cold water isolation valves above electric transformer & equipment.

3. Domestic Cold Water: The existing main domestic cold water isolation valves shall be relocated. These valves and piping were installed directly above the electric transformer and switch board which is a direct NEC code violation. They shall be relocated away from the electrical equipment. Domestic water supply and distribution shall be sized and designed per CPC 2007 chapter 6.

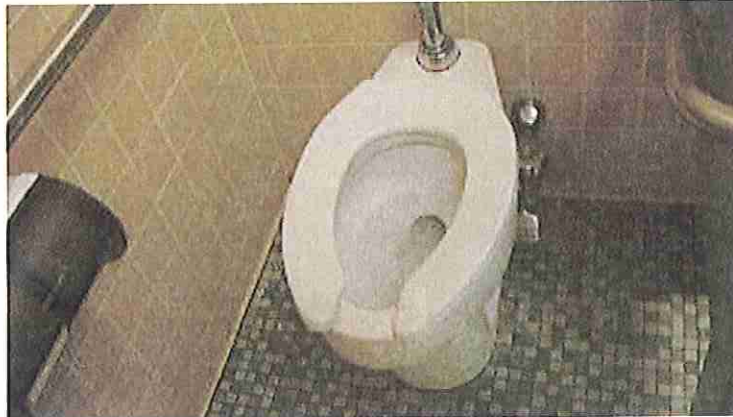
2. Plumbing Fixtures: The existing plumbing fixtures are generally past their service and utilize much more water than is currently utilized in modern plumbing fixtures. See figures P3 through P6. Architect to confirm that some fixtures do not meet current ADA requirements.

Figure P3: Toilet with flush valve

2. Plumbing Fixtures: The plumbing fixtures should be replaced in their entirety. For water conservation, new low flow fixtures should be installed including: Dual flush water closets (or low flow water closets), low flow lavatories, low flow shower heads. Plumbing fixtures shall be designed per CPC 2007 chapter 4. We recommend that all plumbing fixtures be selected to be low consumption, thus saving both domestic water usage as well as energy for domestic hot water heating. Architect to confirm that some fixtures do not meet current ADA requirements. We recommend the following throughout:

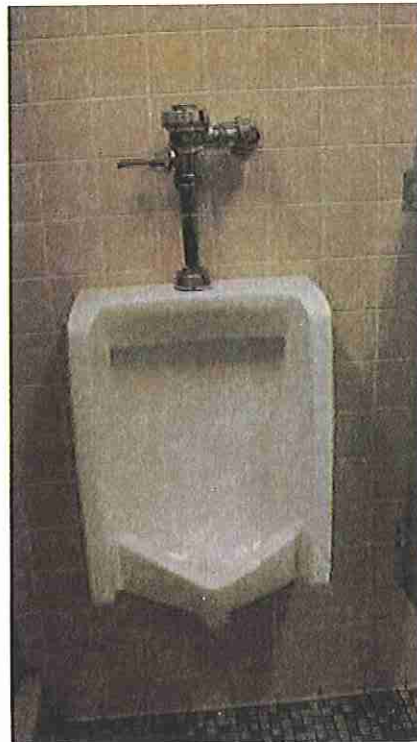
Figure P4: Urinal with flush valve

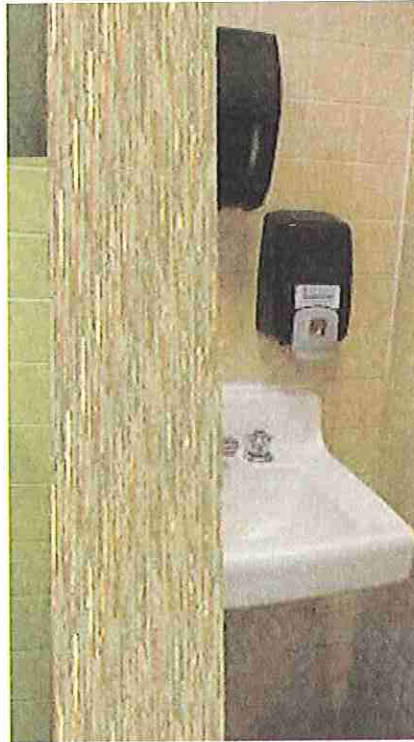
Figure P5: Lavatory

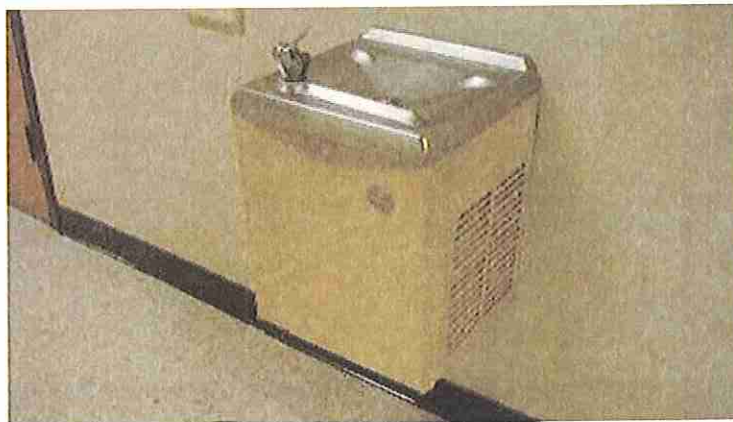
Figure P6: Drinking Fountain

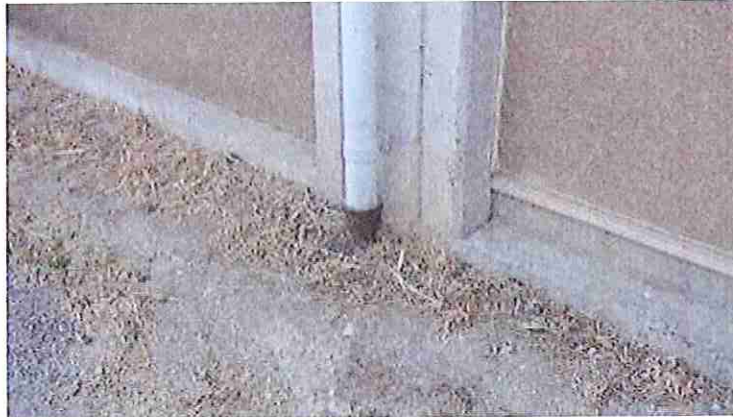
6. Roof Storm Drainage: All rain water from the roof is drained down through many rain water leaders located throughout the building. The rainwater leaders are then hard-pipe connected into the site storm drain system. See figure P7. There are no storm drain backflows reported. For due diligence we recommend that the system be further investigated via camera investigation prior to re-use to validate its life.

Figure P7: Typical rainwater leader hard-piped to site storm drain system.

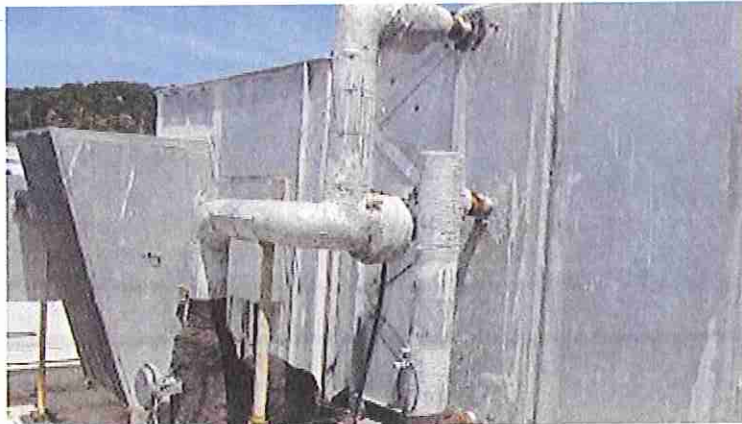
- a. AHU-1: Serving the Theater side comprised of the Lobby, Theater, Stage, Dressing Room, Make-Up Room, Green Room and Control Room. This AHU-1 is located on the roof and is in poor condition. Pipes and insulation are severely corroded and deteriorated. There have been several attempts to patch and fix the pipes and insulation. The fan motor and bearings are worn out and generate a lot of noise. The unit is well beyond its useful service life. See Figure M1 through M4. Due to the severe odors in the buildings and the clear signs of leaks, we recommend that the District engage the services of a hygienist to test the air handling systems and ductwork.

Figure M1: AHU-1 Right Side

In general the existing HVAC system of this building is extremely inefficient to operate. We recommend complete system replacement of the air handling units with all new. The new air handling units will be replaced with commercial grade (manufacturers such as Governair, Temtrol, Haakon) variable volume units designed and built to operate for forty years. All units will be double wall, with plug fans, variable frequency drives, pre-filter, Merv-13 final filter, chilled water coil with condensate drain, heating hot water coil, air flow measuring station for outside air measurement, 0-100% modulating economizer, and smoke detection for fan shutdown. The air handling units will continue to be located in the main mechanical room in the basement of the building. The existing outside air louver will be expanded to support 100% outside air supply from the exterior louver at no more than 500 feet per minute. Since there is no economizer relief for the building and the building gets over pressurized, we recommend the installation of pressure relief fans for proper operation of the economizer. These fans will be located on the roof and connected to the ceiling plenum. Fans will be provided with variable frequency drives to maintain an appropriate space pressure. The air handling units will be provided with DDC controls for energy management routines. All controls will tie into the existing system being used currently on the campus.

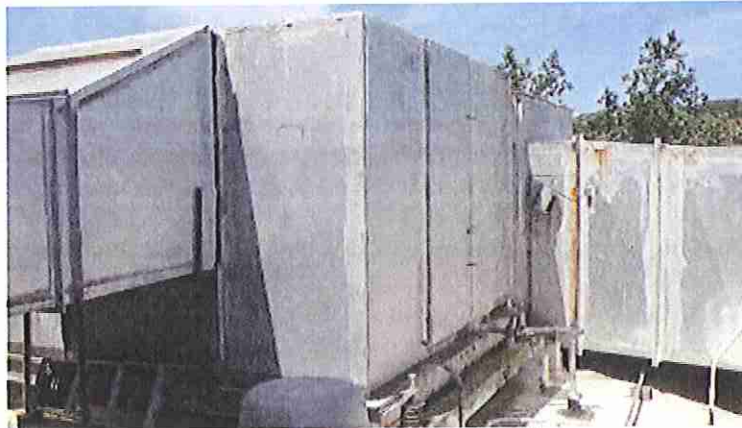
Figure M2: AHU-1 Left Side

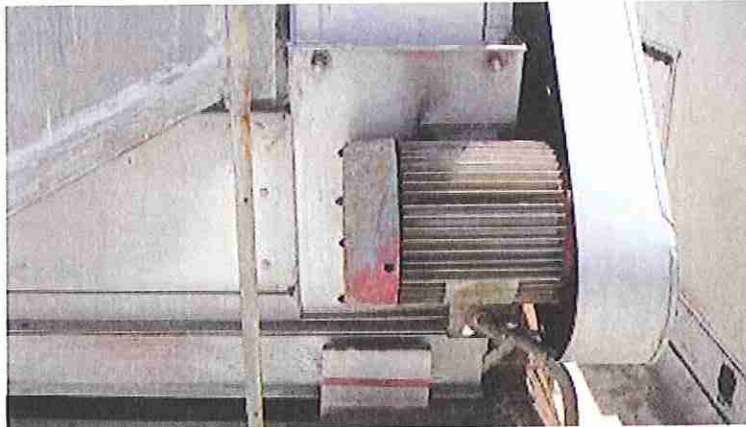
Figure M6: Return fan motor with bad bearing.

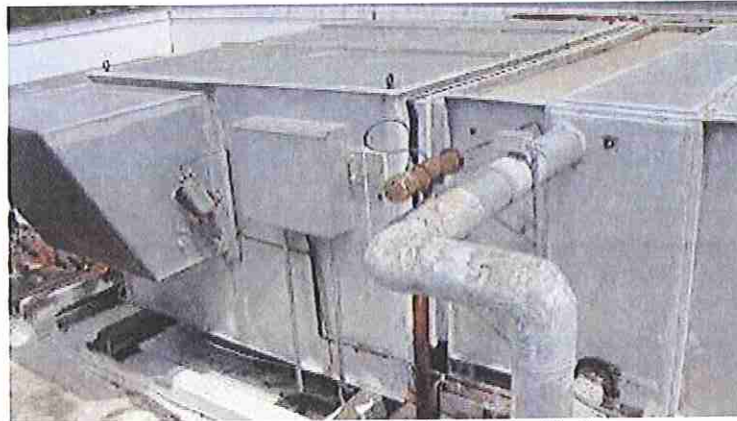
- b. AHU-2: Serving the Classroom side comprised of the Choral Room, Piano Room, Instrumental Room, and Practice Rooms. This AHU-2 is located on the roof and is in poor condition. Pipe insulation, isolation & control valves are severely corroded and deteriorated. See Figure M22 & M23. Fan belt has been severed and broken for quite some time yet the fan motor is still running. Notice for immediate belt replacement and service was sent out to the campus M&O department. See Figure M21. The unit is well beyond its useful service life. See Figure M7. Due to the severe odors in the buildings and the clear signs of leaks, we recommend that the District engage the services of a hygienist to test the air handling systems and ductwork.

Figure M7: AHU-2 Air Handling Unit.

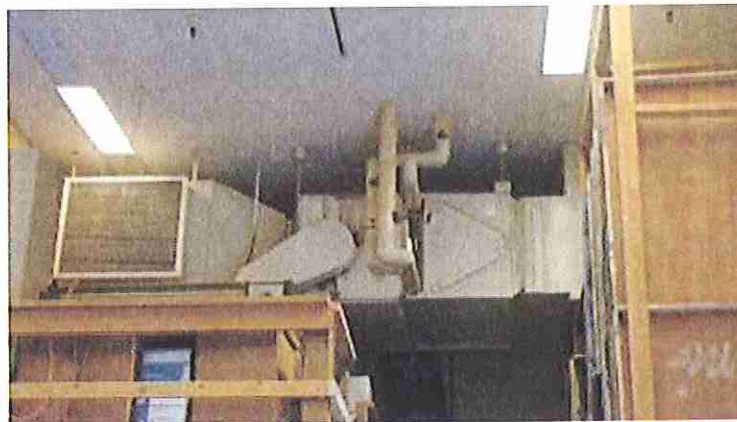
- c. HV-1: Serving the Workshop and Storage. This heating and ventilating unit is located up high in the corner of the ceiling of the Workshop Area. It is inaccessible. Based on our observation, the unit seems antiquated and is well beyond its useful service life. See Figure M8. Due to the severe odors in the buildings and the clear signs of leaks, we recommend that the District engage the services of a hygienist to test the air handling systems and ductwork.

Figure M8: Heating Ventilating Unit

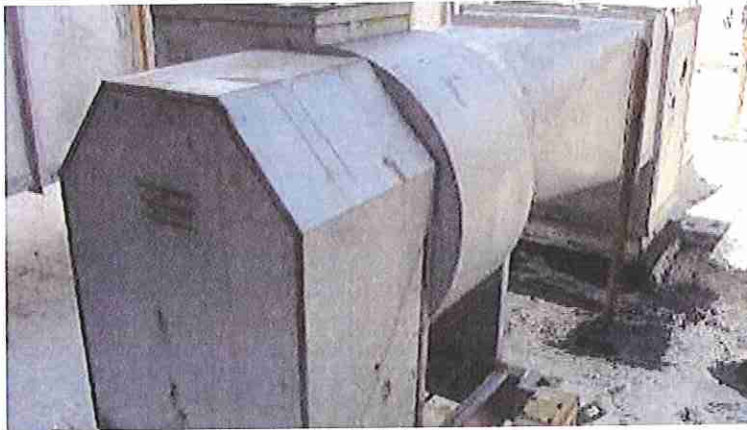
- e. E-1: This roof mounted exhaust fan is serving the Make-Up Room, Green Room and Control Room. The unit shows visible corrosion and water proofing problems at the duct penetration through the roof. The unit is past its useful service life. See Figure M9.

Figure M9: E-1 Exhaust Fan

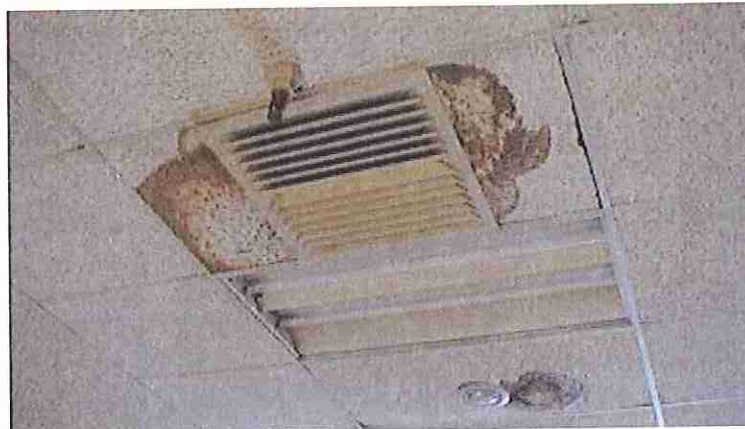
Ductwork and Air Devices: Existing ductwork has extensive air leakage at the duct joints. Air supply/return registers showed visible smudge and dust. See Figure M20. Due to the severe odors in the buildings and the clear signs of leaks, we recommend that the District engage the services of a hygienist to test the air handling systems and ductwork

Figure M20: Air supply register at the ceiling.

2. Ductwork: The existing ductwork is over 10 years past its service life. We recommend all ductwork to be replaced. The new ductwork will support the supply air and return air for the whole building, estimated at 75,000 cfm. All main ductwork will be medium pressure ductwork and will connect to terminal boxes. All ductwork downstream of the terminal boxes will be low pressure ductwork. Provide all new duct supports and seismic bracing of ductwork throughout.

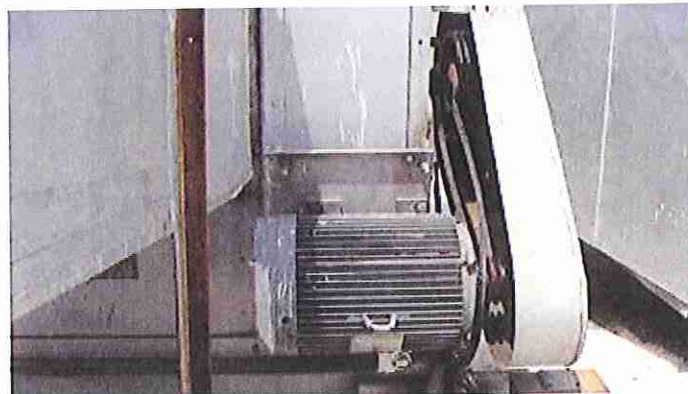
Figure M21: AHU-2 fan belt is snapped, motor is still running!

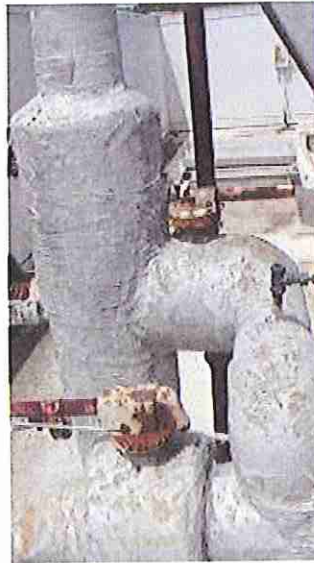
Figure M22: AHU's isolation valves showed extensive corrosion

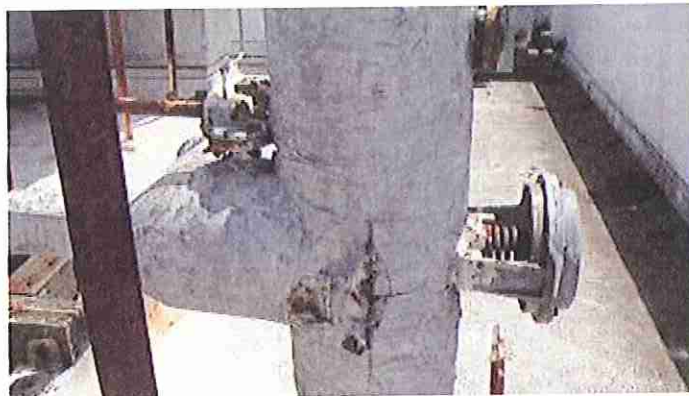
Figure M23: AHU's control valve showed extensive corrosion

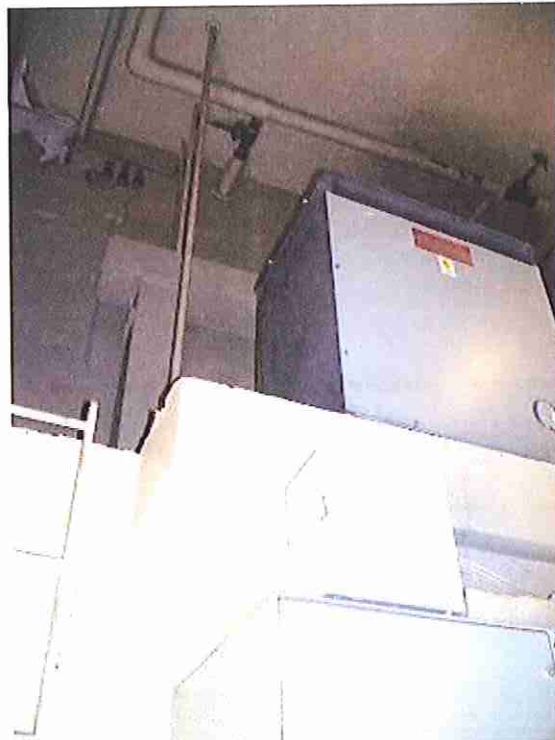
Figure 3 – Plumbing Water Pipes above the Electrical equipment

- c. Existing plumbing pipes are routed above electrical equipment, NEC 110.26(F)(1)(a) requires that dedicated space 6 feet above an electrical equipment be free of foreign system such as piping, duct, etc. This is to avoid damage to electrical equipment from condensation, leaks, in such foreign system. We recommend relocating all piping systems over electrical equipment or in electrical rooms.

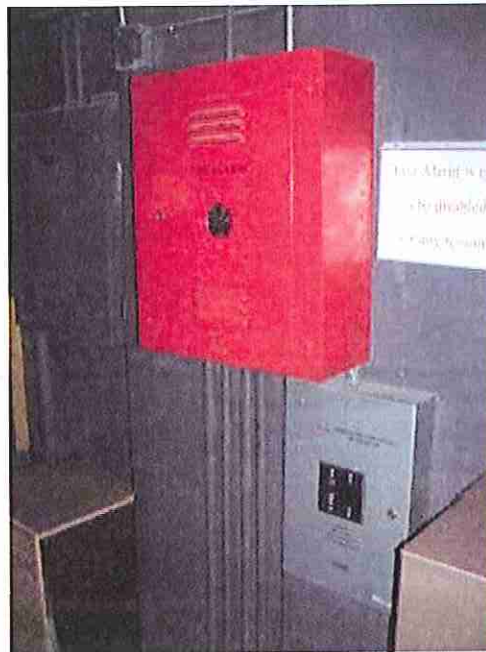
- 3. Fire Alarm System: The existing fire alarm system for the Building is by Standard. The Main Fire Alarm Control Panel is located in the backstage, west side of the Theater. The existing Fire Alarm System currently provides audible notification and for initiation devices only in Common areas and Corridors. Pull stations are located within close proximity of main entrance and exit doors. No visual device coverage was observed. The Fire Alarm System is a non-addressable type and is the original system installed when the Building was constructed in 1974.

Figure 13 – Fire Alarm Control Panel behind the Stage in the Theater Area

- a. The existing Fire Alarm System is non-addressable and out-dated. The installation of Fire Alarm devices are not ADA compliant. We recommend a new, complete, supervised, and annunciated Fire Alarm System be installed for this project. The Fire Alarm System shall comply with NFPA, NEC, and ADA requirements and shall consist of manual pull stations, combination audio/visual alarms, and strobes. Ceiling mounted smoke and heat detectors should be provided in all electrical and mechanical rooms, storage, shafts, and along all major corridors in accordance with code and as required by the State Fire Marshall.
