STRUCTURAL EVALUATION OF

**SOLANO COMMUNITY COLLEGE  
THEATER BUILDING**

Fairfield, California

DASSE Design Project No. 08B173

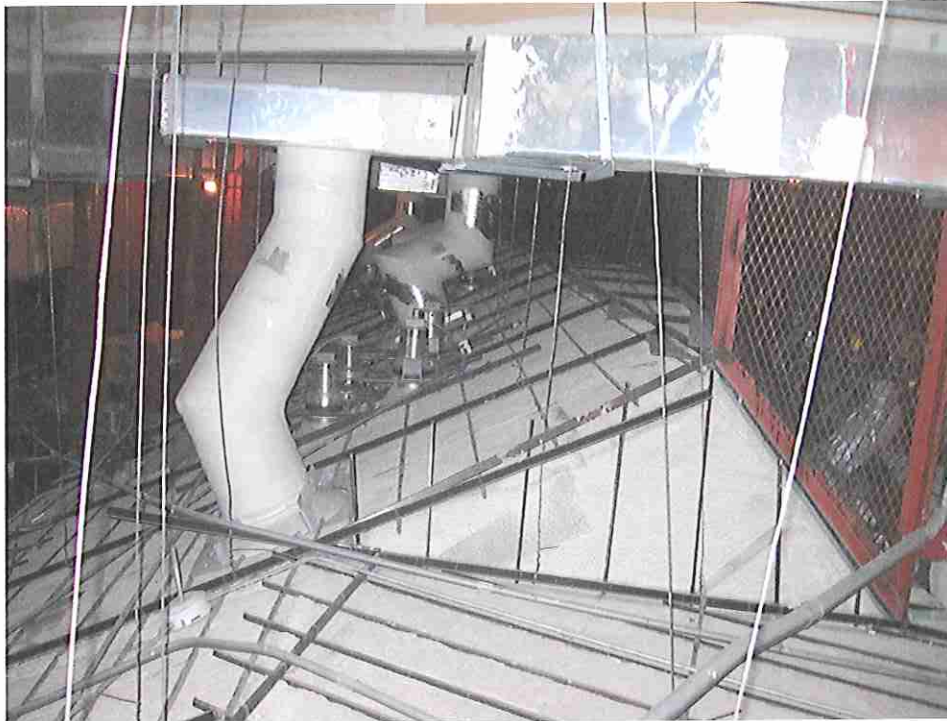
Photo 1 Aud. Ceiling

8. Existing suspended plaster ceiling in the Auditorium building has no lateral bracing.

The ceiling of the Auditorium consists of suspended plaster ceiling and lacks lateral bracing in longitudinal and transverse direction.

7. Provide new plywood shear wall, hold-downs and attachment to the existing concrete wall.
8. Provide new unistrut lateral bracing at 8'-0" on center in both directions.

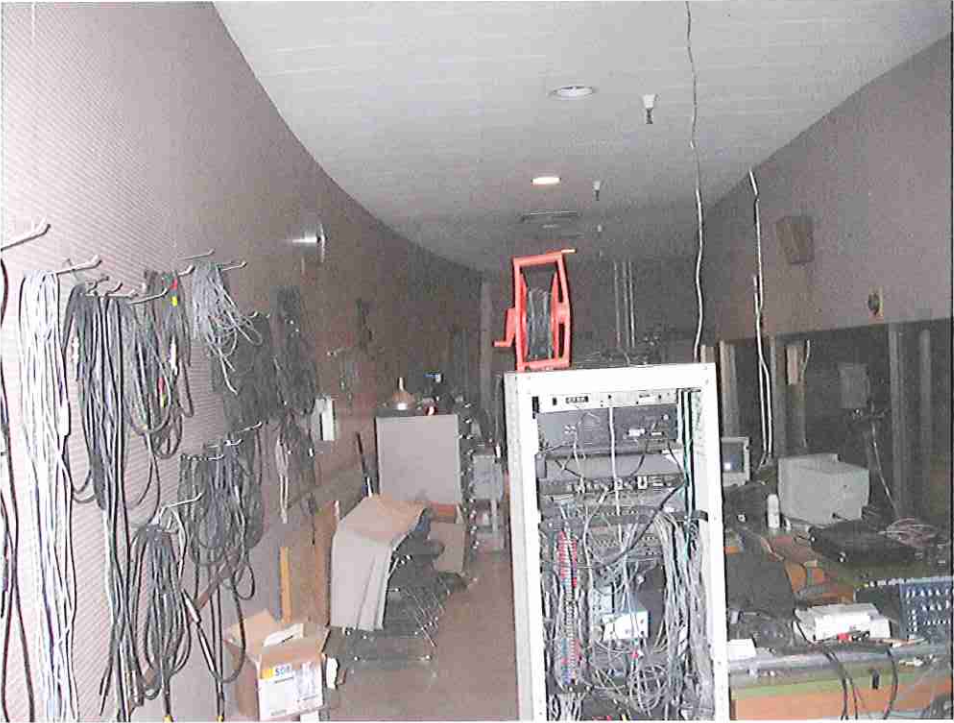
Photo 4 Control Room

1. The Control room floor located above the main entrance lobby needs lateral bracing in the transverse direction. This floor diaphragm lacks lateral bracing.

1. The Control room floor diaphragm lacks lateral bracing in the north-south direction. The current diaphragm aspect ratio is approximately 7:1 which exceeds the code allowable value of 3:1.

1. Provide lateral bracing in the north-south direction as shown in sketch numbers 1, 11 and 12
2. Provide new shotcrete walls to strengthen existing shear walls on gridline 10 as shown in sketch numbers 1, 4 and 5.

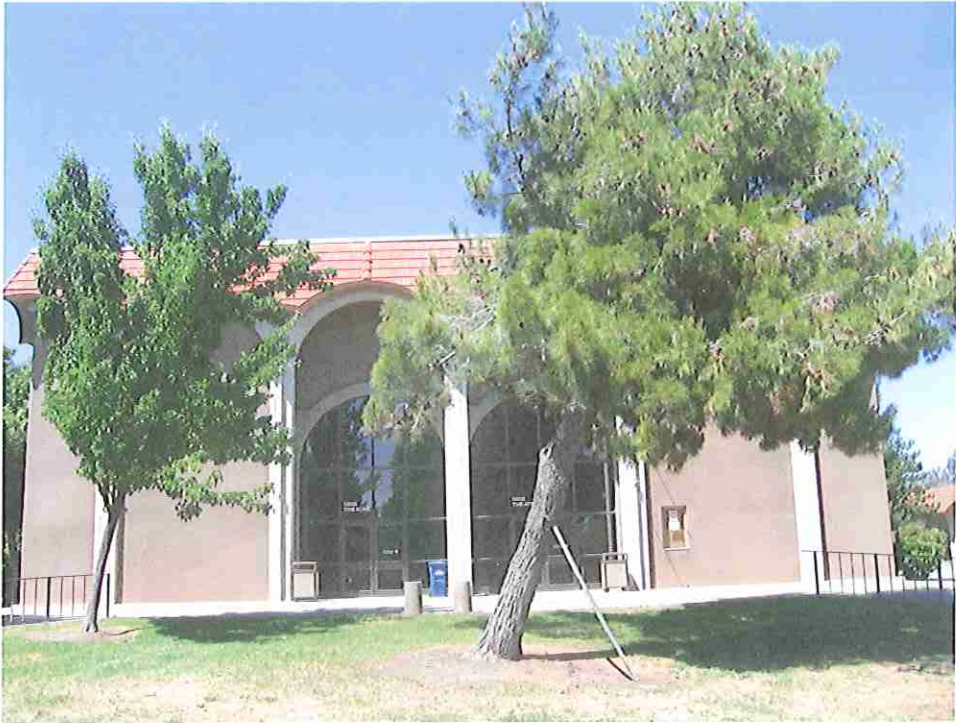
Photo 7 Front Entrance

It appears that the front entrance canopy structure was not constructed as shown in the structural drawing between grid lines A to G and lines 1 to 0 based on the site visit and review of the photographs of this area.

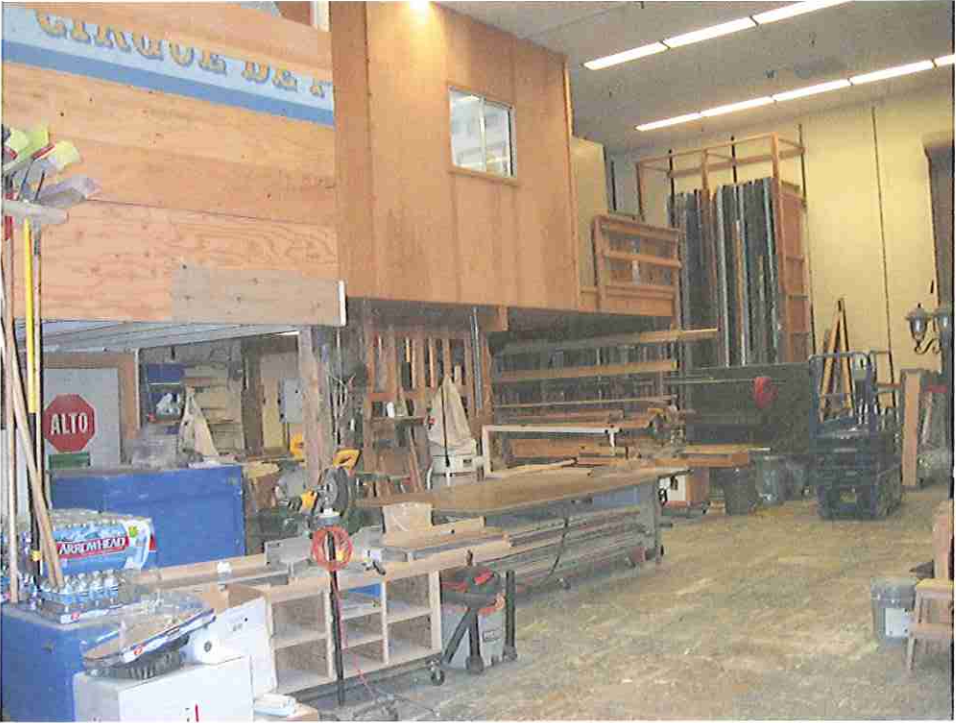
Photo 8 Shop Office

7. Existing mezzanine in the Shop building (currently used as office) needs to be seismically retrofitted.

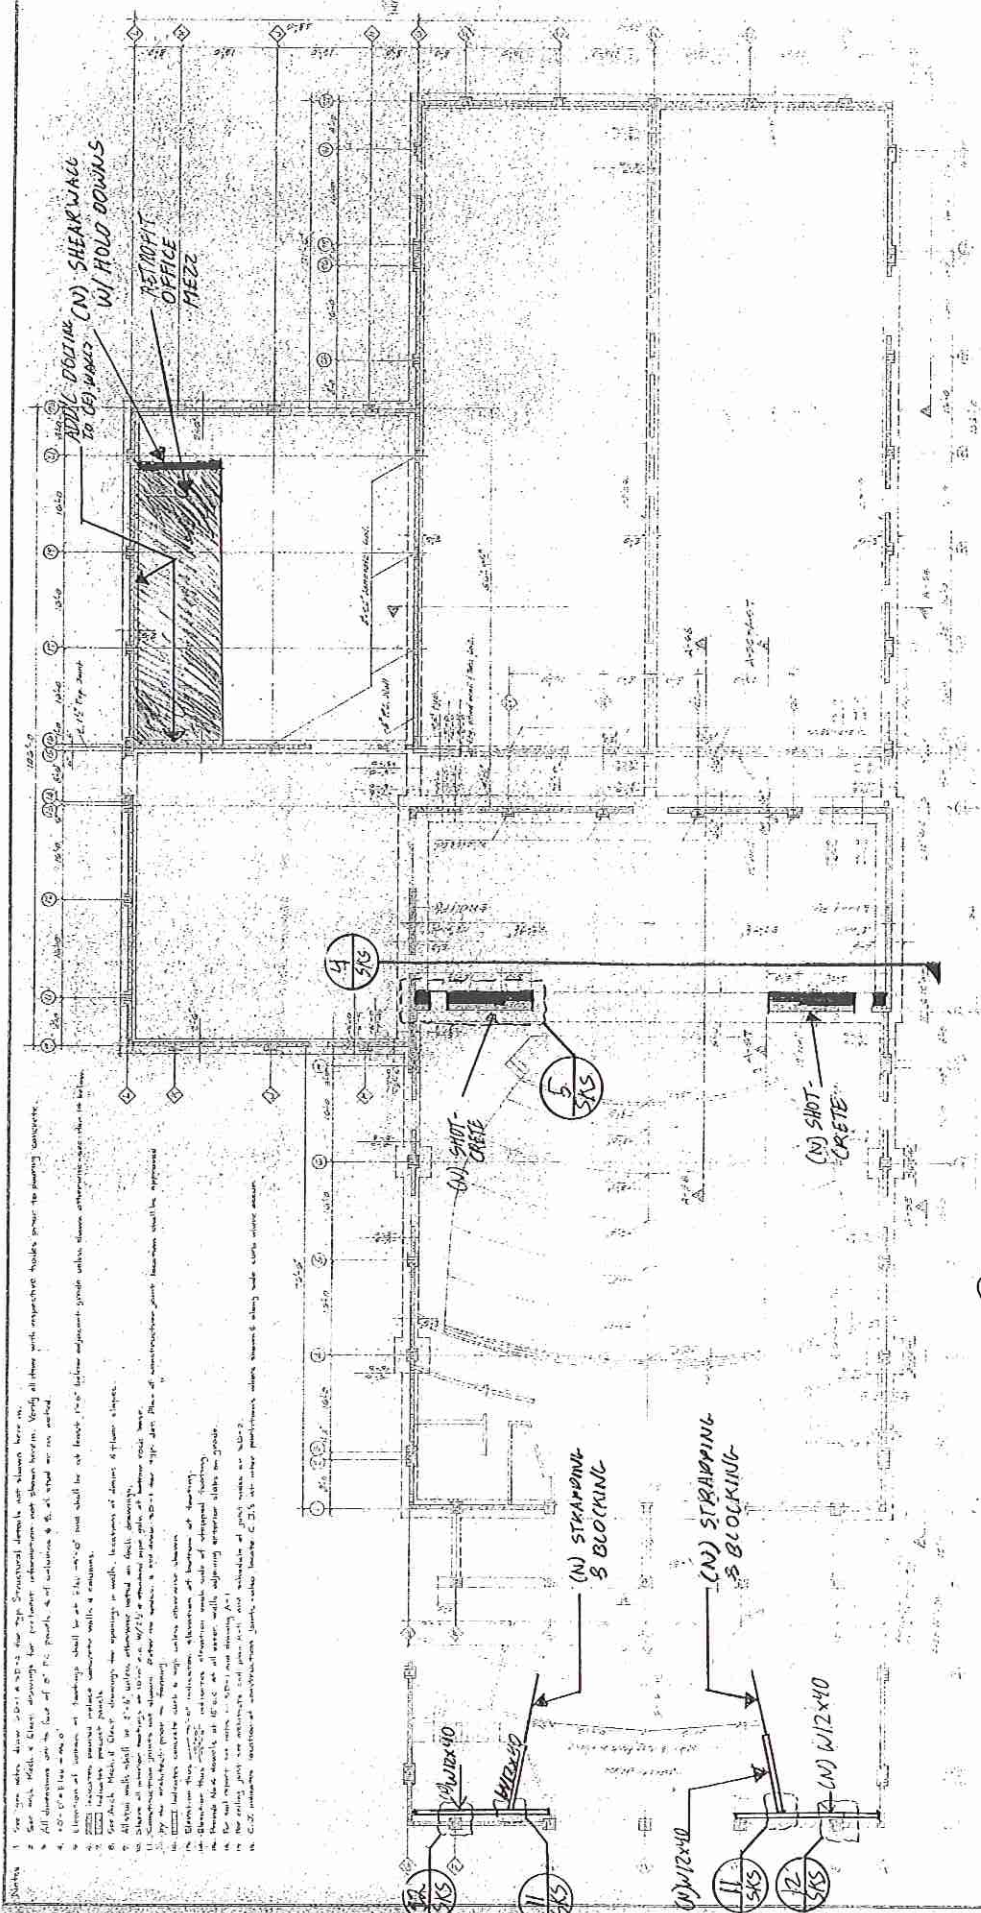
**SKS-1 GROUND RETROFIT PLAN**

2. The existing shear walls at gridline 10 between grids A to C and E to G are overstressed in the lower level due to wall overturning moments and need to be strengthened.

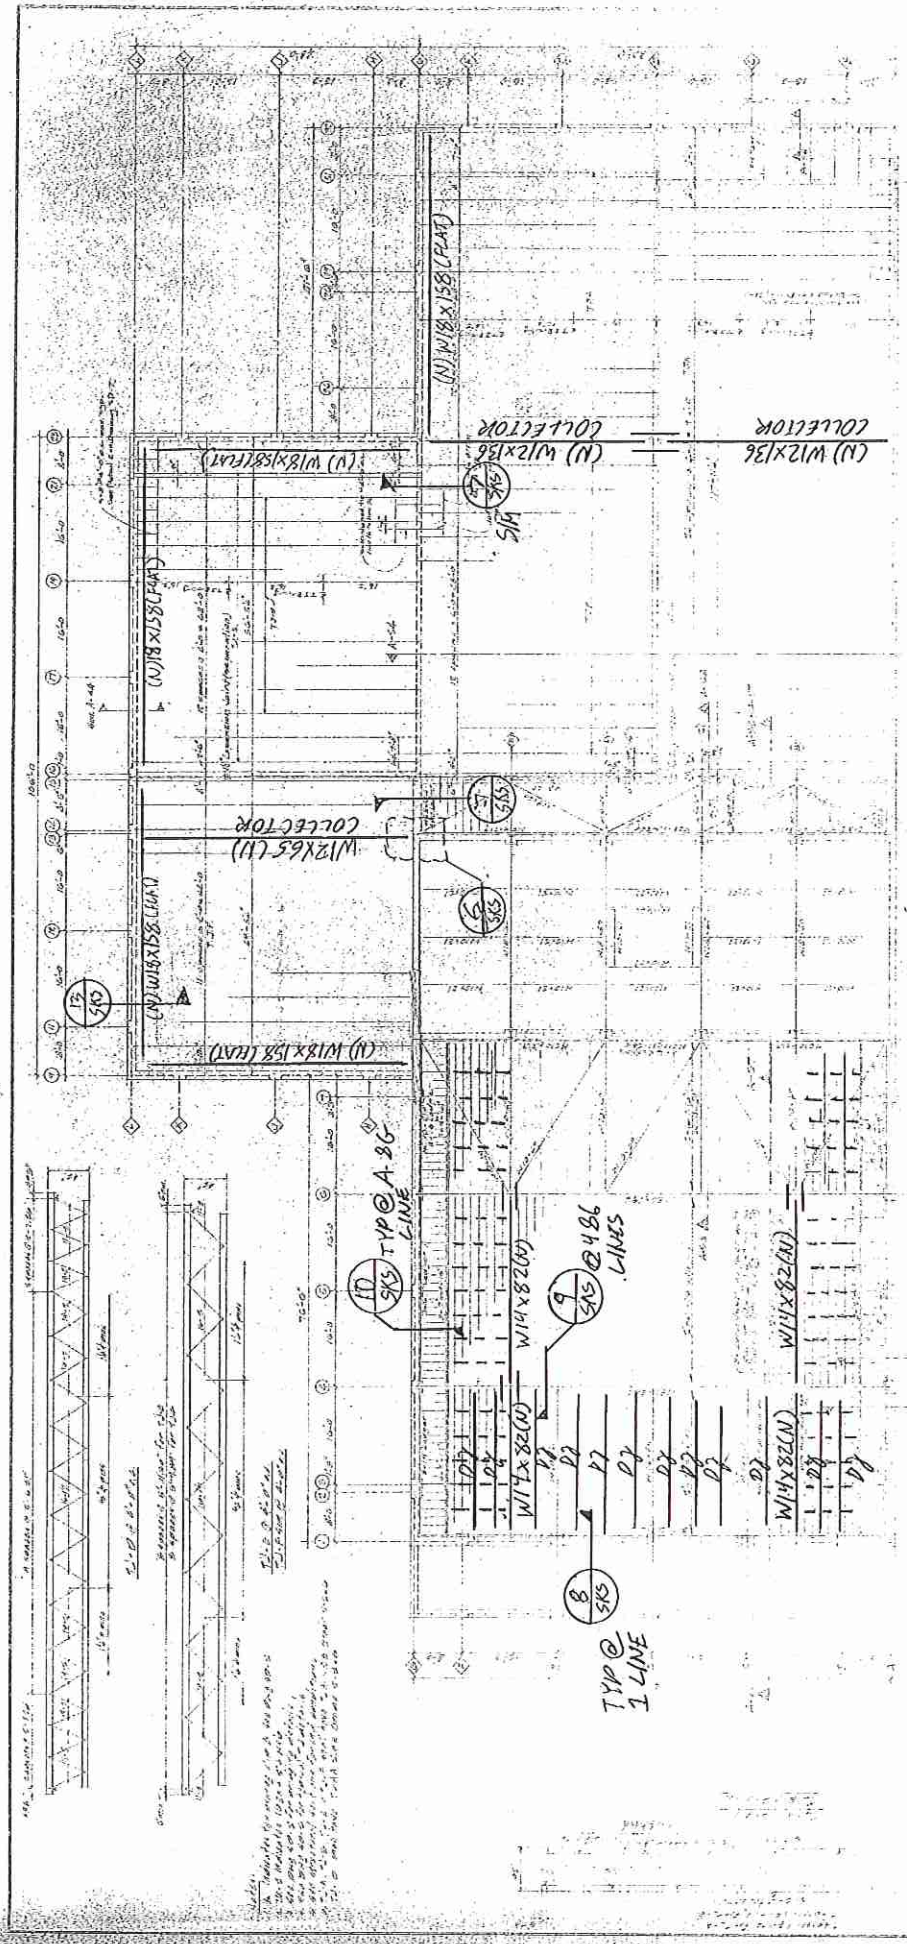
D7 - DOUBLE JOIST SKS-2 ROOF RETROFIT PLAN

3. The low roof diaphragm of the Auditorium Building between gridlines 9/13 and G/L needs a new collector line on gridline 13 to resist diaphragm shear and to drag the lateral load into the shear wall on line 13.

4. The low roof diaphragm of the Music Building is overstressed and needs a new collector on gridline 23. This collector will in turn drag the seismic loads into the shear wall on gridline 23.

3. Provide new collector member as shown in sketch numbers 2, 6 and 7. Also, provide new nailing along the collector line as shown in sketch number 3.
4. Provide new collectors on gridline 23 as shown in sketch number 2. Also, provide new nailing along the collector line as shown in sketch number 3.

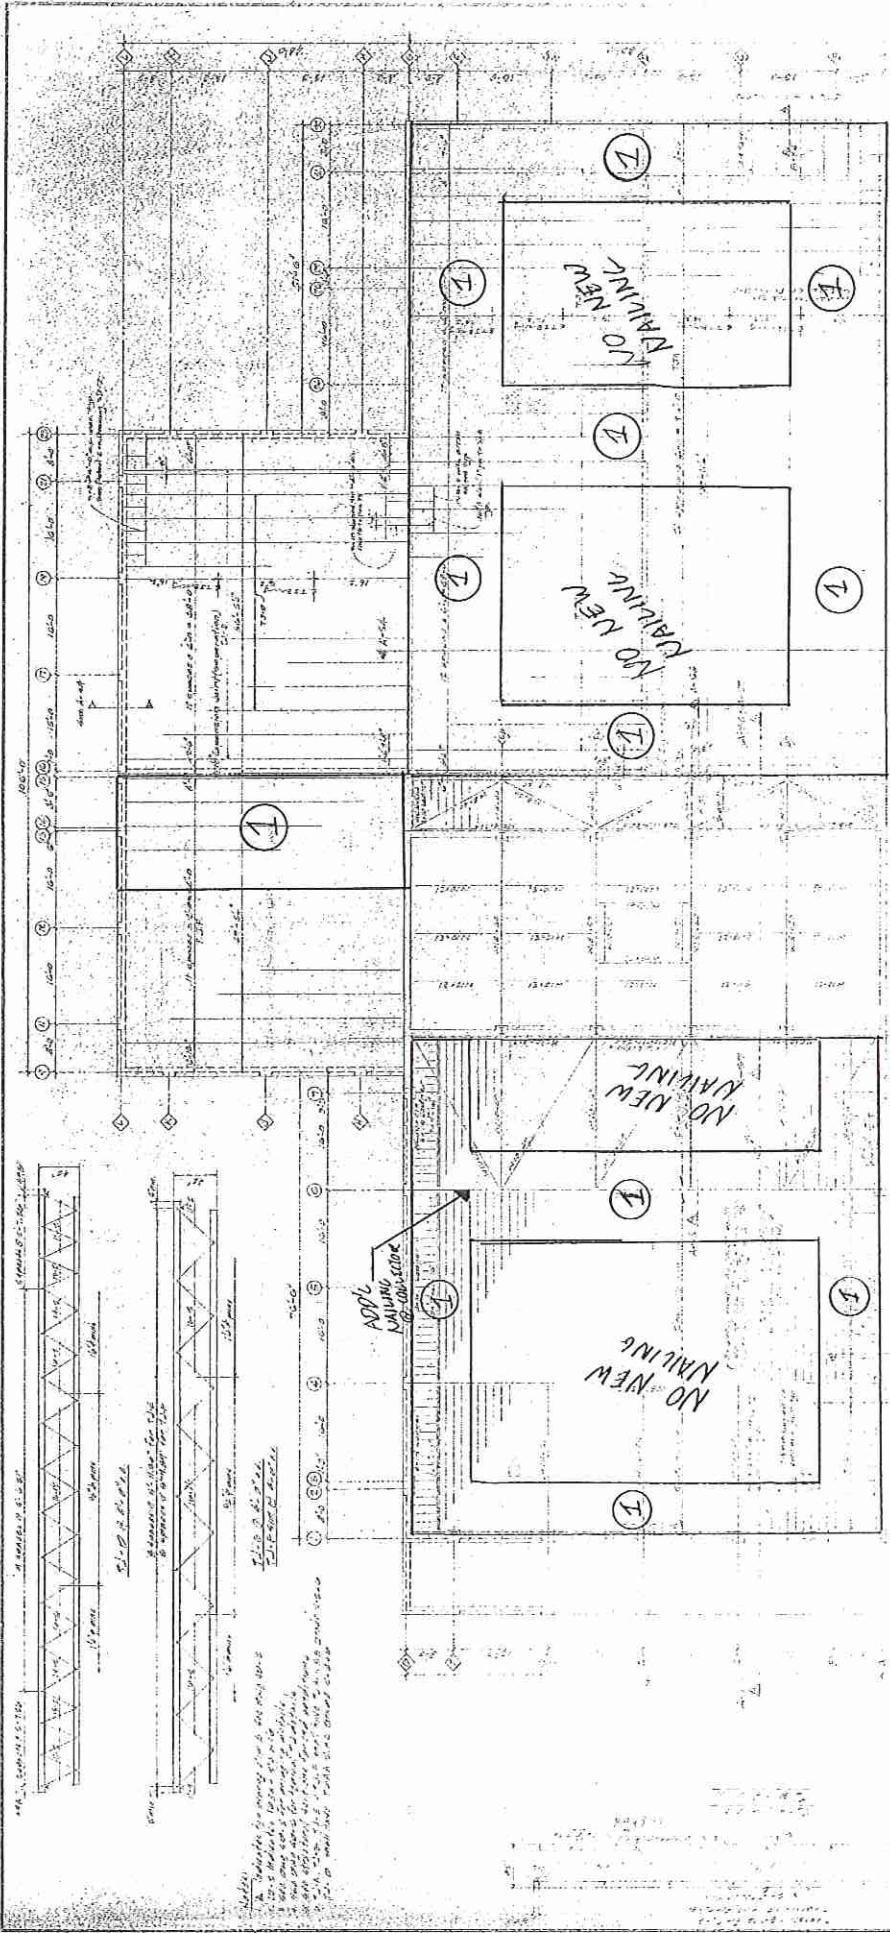
SKS-3 ADD'L ROOF NAILING PLAN

6. The Auditorium roof diaphragm edge nailing is overstressed and needs to be strengthened along gridlines 1, 10, A and G. Similarly the Music building roof diaphragm edge nailing is also needs overstressed.
  7. The existing mezzanine level within the Shop building, which is currently being used as office space, lacks lateral system to resist seismic loads and needs to be retrofitted. No structural and architectural drawing for this office area was provided and it is unknown whether this was constructed with the DSA approval.
- 4.2 The Auditorium ceiling lacks lateral bracing. Provide new unistrut lateral bracing to adequately brace the existing suspended plaster ceiling.

5. Provide new wall out-of-plane ties for the Auditorium building as shown in sketch numbers 2, 8, 9 and 10.
6. Provide additional nailing as shown in sketch number 3 for the Auditorium building, Make-Up room and the Music building.

① ADD NAILING TILL 10d @ 4" O.C. 2 ROWS @ EDGE  
10d @ 12" O.C. FIELD

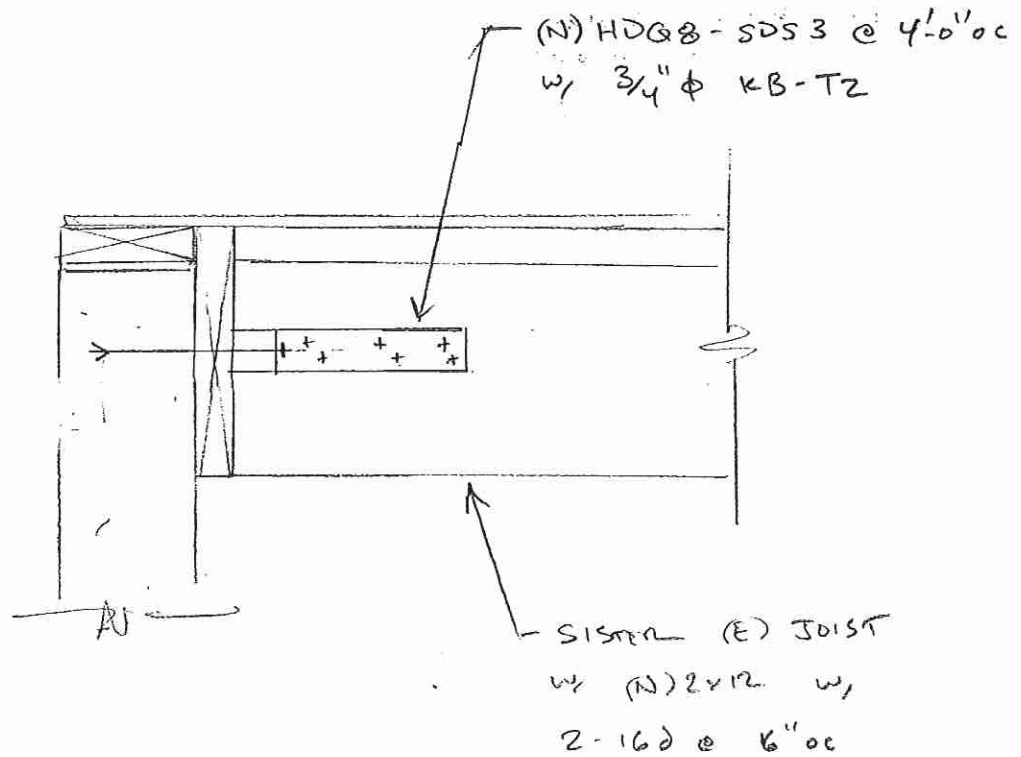
⑧ (N) WALL ANCHOR @ 4'-0" oc AT  
- ADD. ROOF, PARALLEL TO (E) JOIST

5. Connection between the poured-in-place exterior concrete pilasters and the roof diaphragm needs to be strengthened as they are currently inadequate to resist wall out-of-plane forces. This is required all around the perimeter of both buildings.
