Hazardous Materials Survey Report (revised)

Solano Community College
4000 Suisun Valley Road
Building 1100 Portables
Fairfield, CA

RGA Project No: SCC32836

August 8, 2013

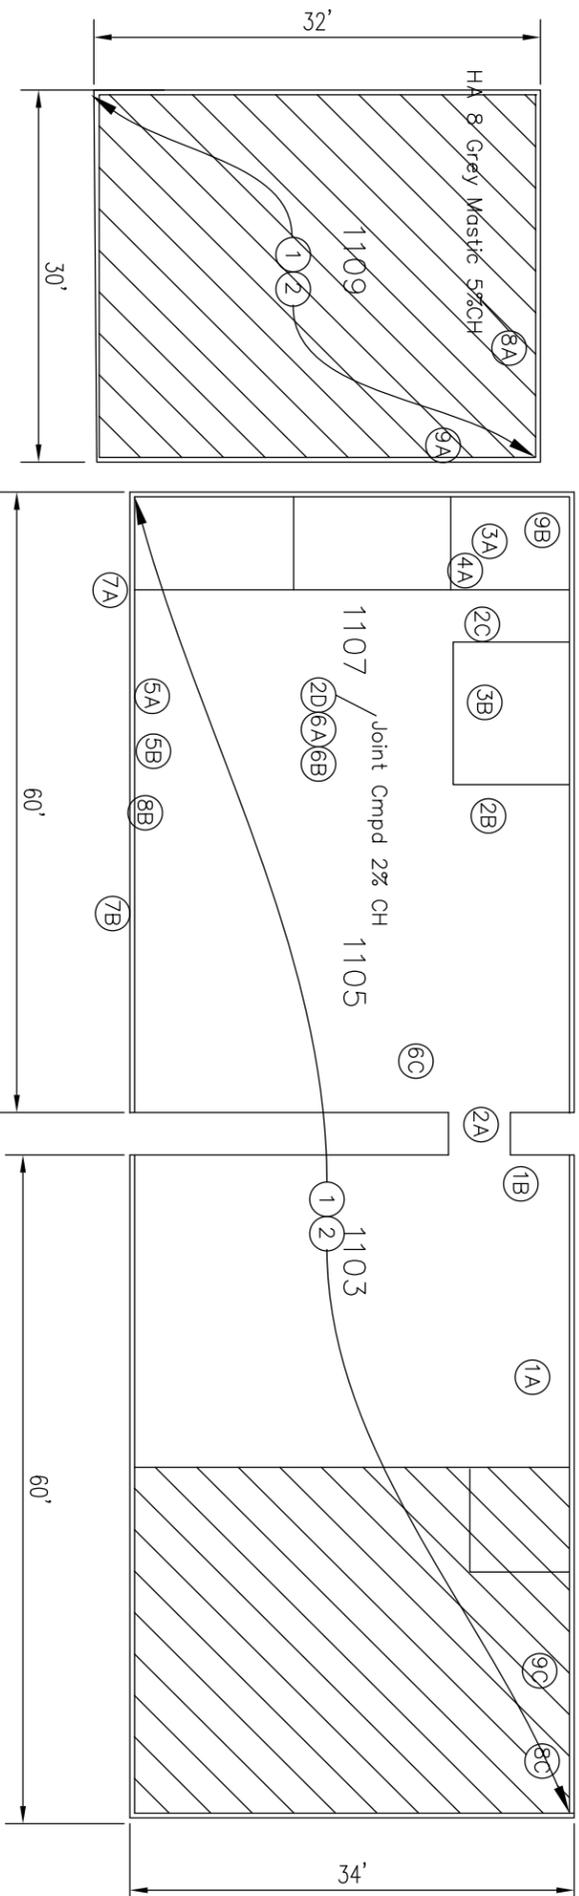
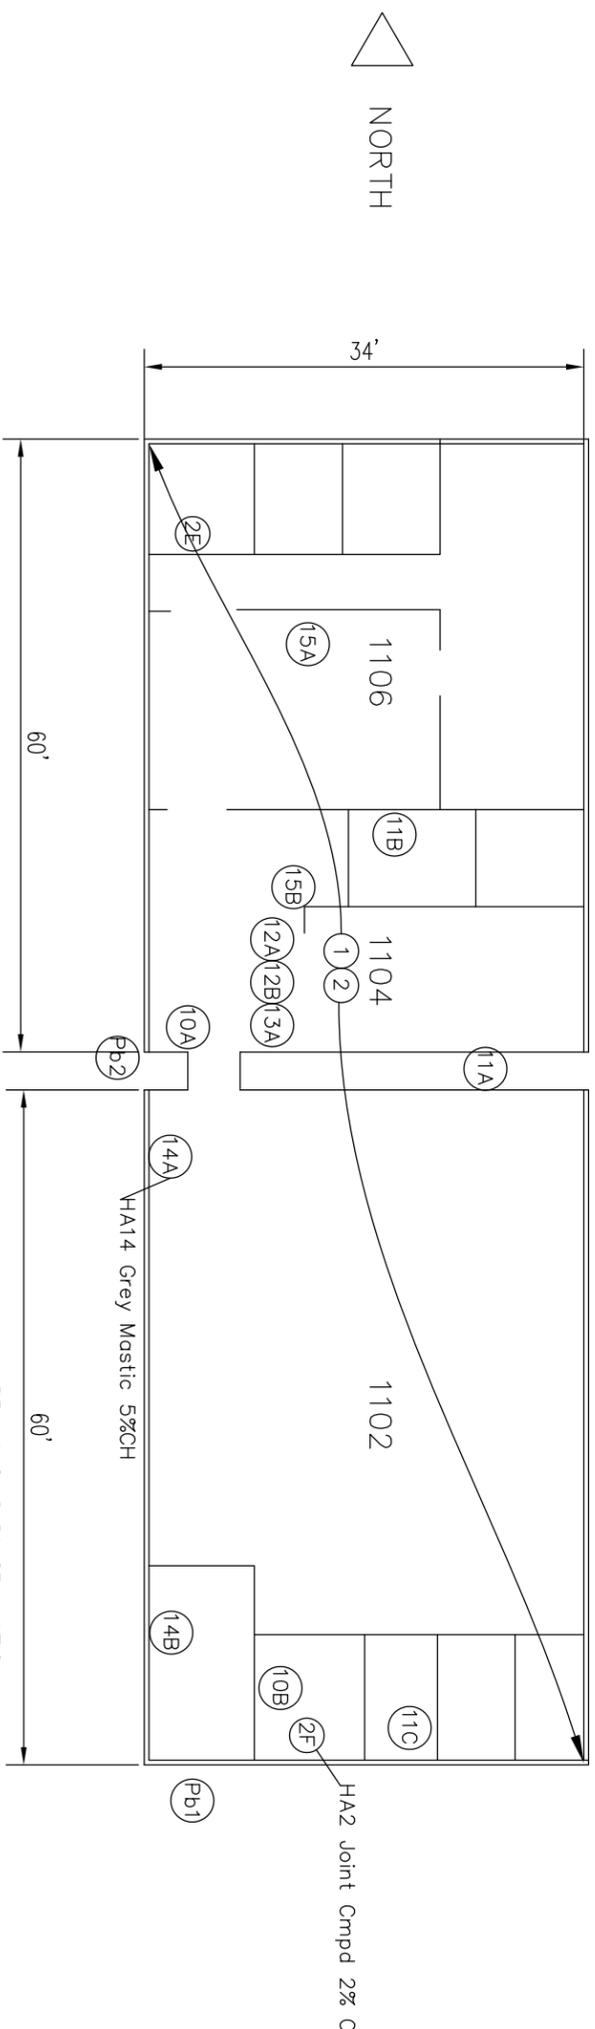
- ① ABATE ALL WALLBOARD AND ASSOCIATED COMPOUND
- ② ABATE ALL GREY ROOFING MASTICS

A. THIS WORK INCLUDES THE ABATEMENT OF WALLBOARD AND JOINT COMPOUND, VINYL FLOOR TILE (MASTIC IS NEGATIVE) AND GRAY ROOFING MASTICS THAT CONTAIN ASBESTOS LOCATED AT THE PORTABLES. ALL ITEMS INDICATED TO BE REMOVED OR ABATED MUST BE VERIFIED AND REVIEW ON SITE BY THE CONTRACTOR PRIOR TO BIDDING. ALL ABATEMENT WORK SHALL BE CONDUCTED IN ACCORDANCE WITH DISTRICT PROVIDED ASBESTOS ABATEMENT SPECIFICATION. CONTRACTOR TO PROVIDE A UNIT PRICE FOR ALL KNOWN OR ASSUMED ASBESTOS CONTAINING MATERIALS. A PLUS OR MINUS 10% OF QUANTITIES BID IS NOT CONSIDERED A CHANGE CONDITION.

E. ALL SHEET NOTES ARE TYPICAL (TYP) UNLESS OTHERWISE NOTED. ABATE AND PROPERLY DISPOSE OF ALL ASBESTOS CONTAINING MATERIALS FROM THE BUILDING AND SURROUND AREA IMPACTED BY THE PLANNED DEMOLITION OF THE PORTABLES.

F. ABATE ALL LOOSE AND STRATIFIED LEAD PAINT FROM THE INTERIOR AND EXTERIOR OF THE PORTABLES IN ACCORDANCE WITH CAL-OSHA 1532.1. USING DUST CONTROL METHODS AND BY PROPERLY TRAINED PERSONNEL.
