**Appendix E:  
Retaining Wall Investigation**

October 30, 2014

Subject: **1683-1699 North Ascot Parkway, Retaining Wall Investigation  
 MI1401083.00**

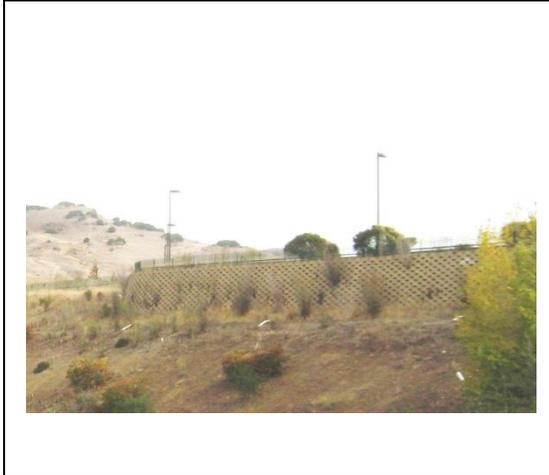
1. At the Dry Stacked Concrete Walls, we found much vegetation growing out of the spaces between the blocks. It should be determined by the block and geo-grid manufacturer if this condition will compromise the retaining wall system. If this condition is determined to compromise the retaining wall system, the vegetation should be removed (**Figure-2 thru 8**).

**Figure 2. West wall showing vegetation.**

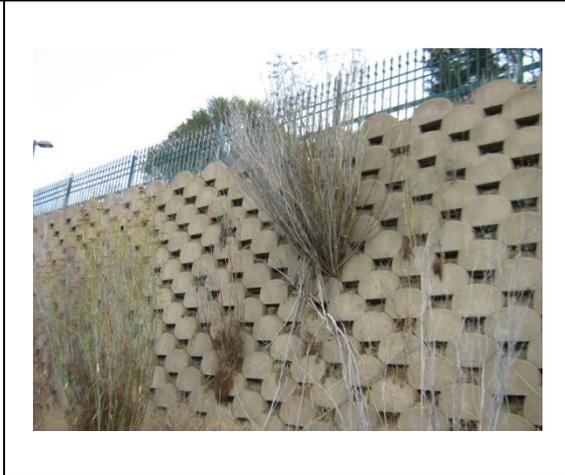
**Figure 3. Vegetation growth @ West wall.**

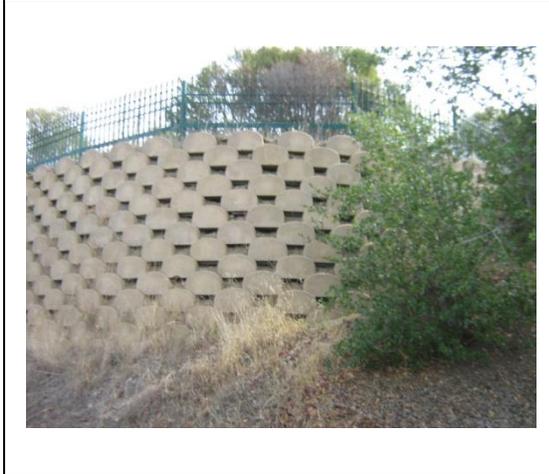
**Figure 4. West wall near Turner Parkway.**

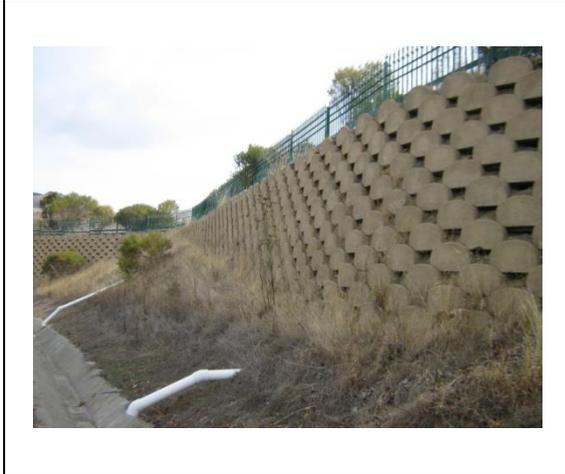
**Figure 5. West wall showing drain pipes.**

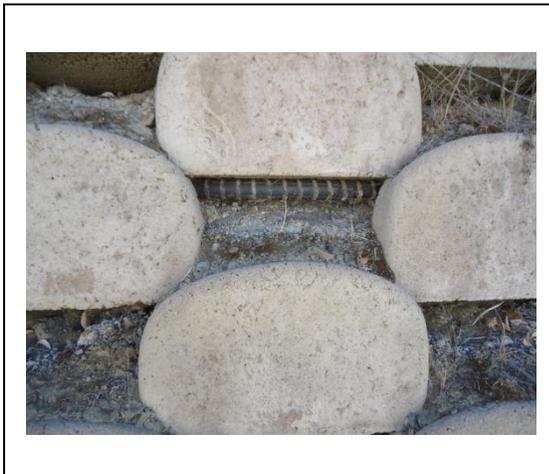
**Figure 6. Soil reinforcing (geo-fabric)**

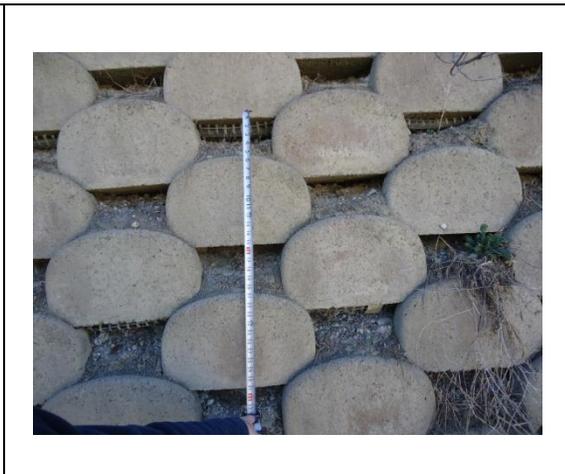
**Figure 7. Soil reinforcing, spacing at 24" oc, vertically.**

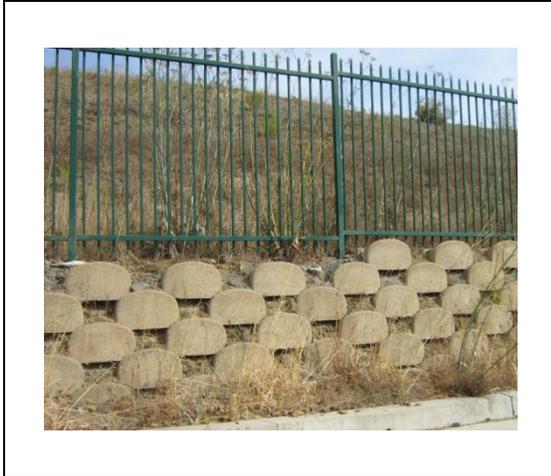
**Figure 8. Low retaining wall with fence.**

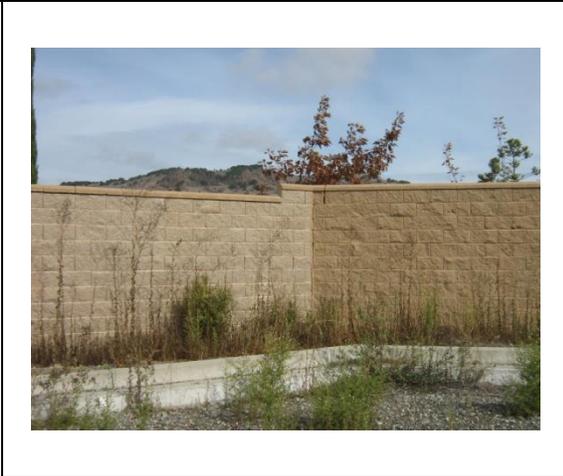
2. At a CMU screen wall on the North property line, we found a cracked joint at a corner and a gap at the cap block. This crack will not affect the performance of the wall. The crack should be repaired with cement mortar (**Figure-9 thru 11**).

**Figure 9. Crack in CMU screen wall.**

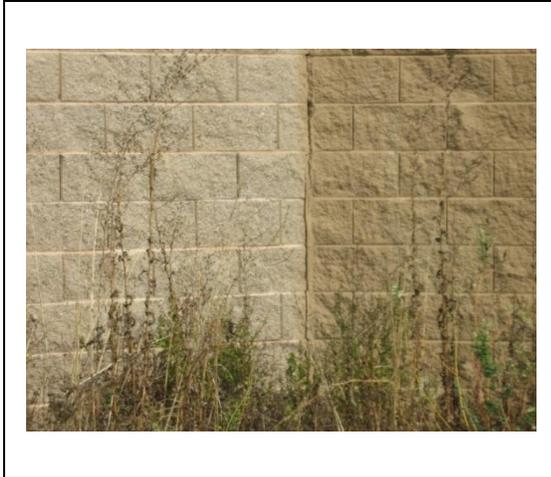
**Figure 10. Crack in CMU screen wall.**

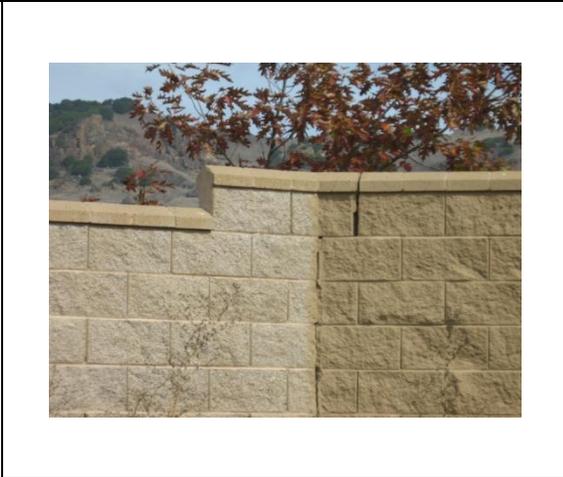
**Figure 11. Crack in CMU screen wall.**
