# PMP Environmental Consulting

March 25, 2021

This letter contains the results of an exterior asbestos and lead survey performed at Buildings 300, 400, 500, 600, 700, 800, 900, 1000, 1200, 1300, 1400, 1500, 1600, 1700, 1700B, 1800, 1800B, 1900, and 2700, Located at 4000 Suisun Valley Road, Fairfield, California on the Solano Community College Campus. All suspect asbestos and lead containing materials that may be disturbed during the upcoming painting project have been sampled. A list of suspect materials identified and sampled are included in this report. The survey was performed on March 17 & 18, 2021 by Shannon Johanson. Mrs. Johanson is a Cal/OSHA Certified Asbestos Consultant and EPA-accredited Building Inspector. See attached personnel certifications.

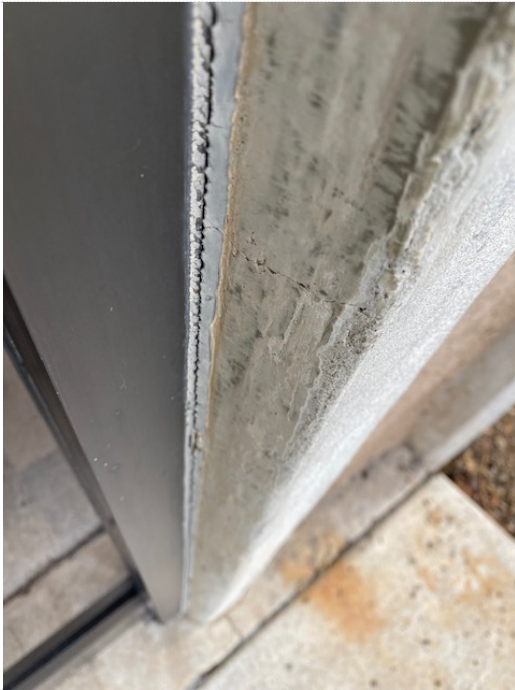
Damage to gray window sealant

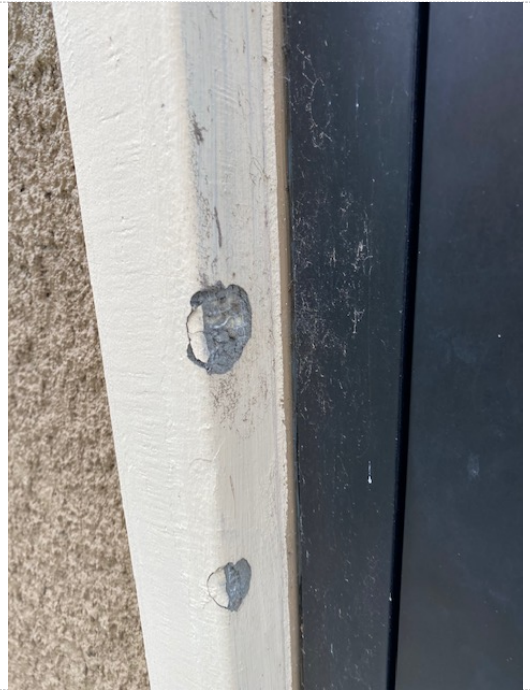
Damaged concrete trim

**Location: 13A, Concrete Building 600, East Side at Door Trim Damage** Lab ID-Version‡: 12424672-1

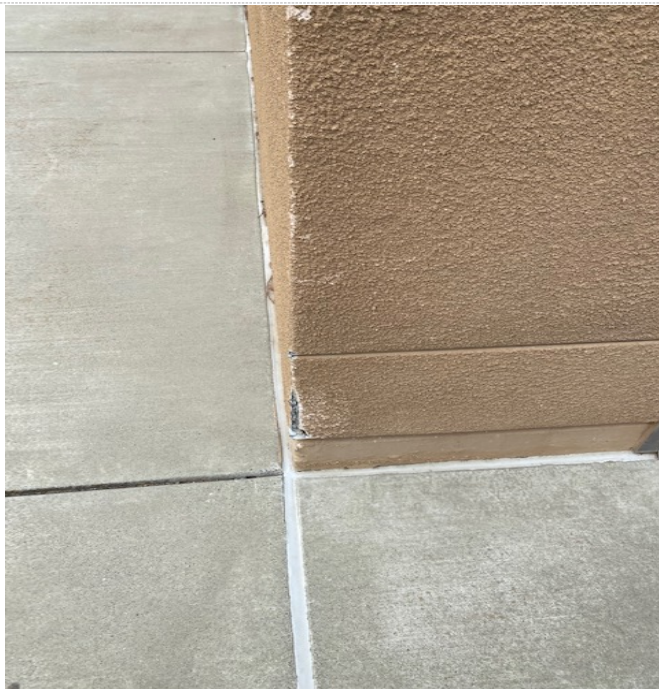
Damaged stucco at corner of Building 1400-Staff

**Location: 01A, Stucco Building 1400-Staff at Damaged Corner**

**Location: 01B, Stucco Building 1400-Staff, SE Corner at Damage**

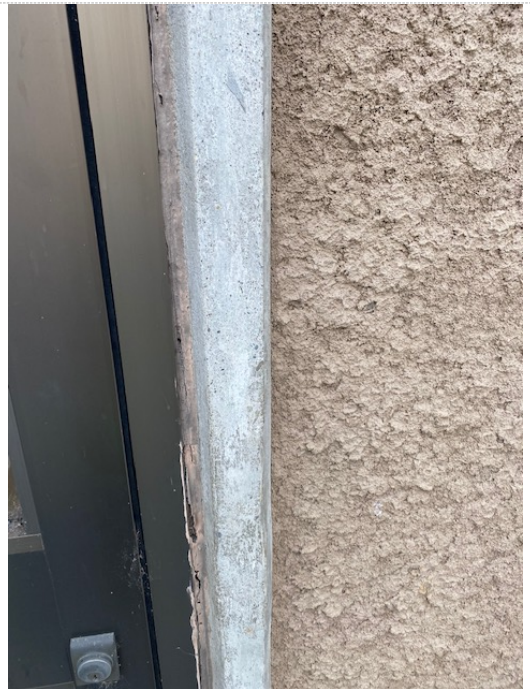
Sample No.	Material Description	Location	Asbestos Content	NESHAP Category	Amount
06C	Brown Window Frame Sealant	Building 1800A	5% Chrysotile	CAT II	Unknown
08C	Brown Door Frame Sealant	Building 1800A	5% Chrysotile	CAT II	Unknown

Damaged asbestos brown frame sealant-Building 1800A

**Location: 08C, Door Frame Sealant-Damaged, Building 1800A, 1819** Lab ID-Version‡: 12424666-1

Care should be taken when prepping paint surfaces on Building 1800A. This building has damaged window and door sealants. These should be removed or repaired prior to painting.
