FAIRFIELD CAMPUS
POOL DECK REPLACEMENT PROJECT
PROJECT NUMBER: 23-006

Geotechnical Evaluation and Geologic Hazards Assessment Pool Deck Solano Community College – Fairfield Campus 4000 Suisun Valley Road Fairfield, California

September 9, 2022 | Project No. 404147002

Geotechnical Evaluation and Geologic Hazards
Assessment
Pool Deck Replacement
Solano Community College – Fairfield
Campus
4000 Suisun Valley Road
Fairfield, California

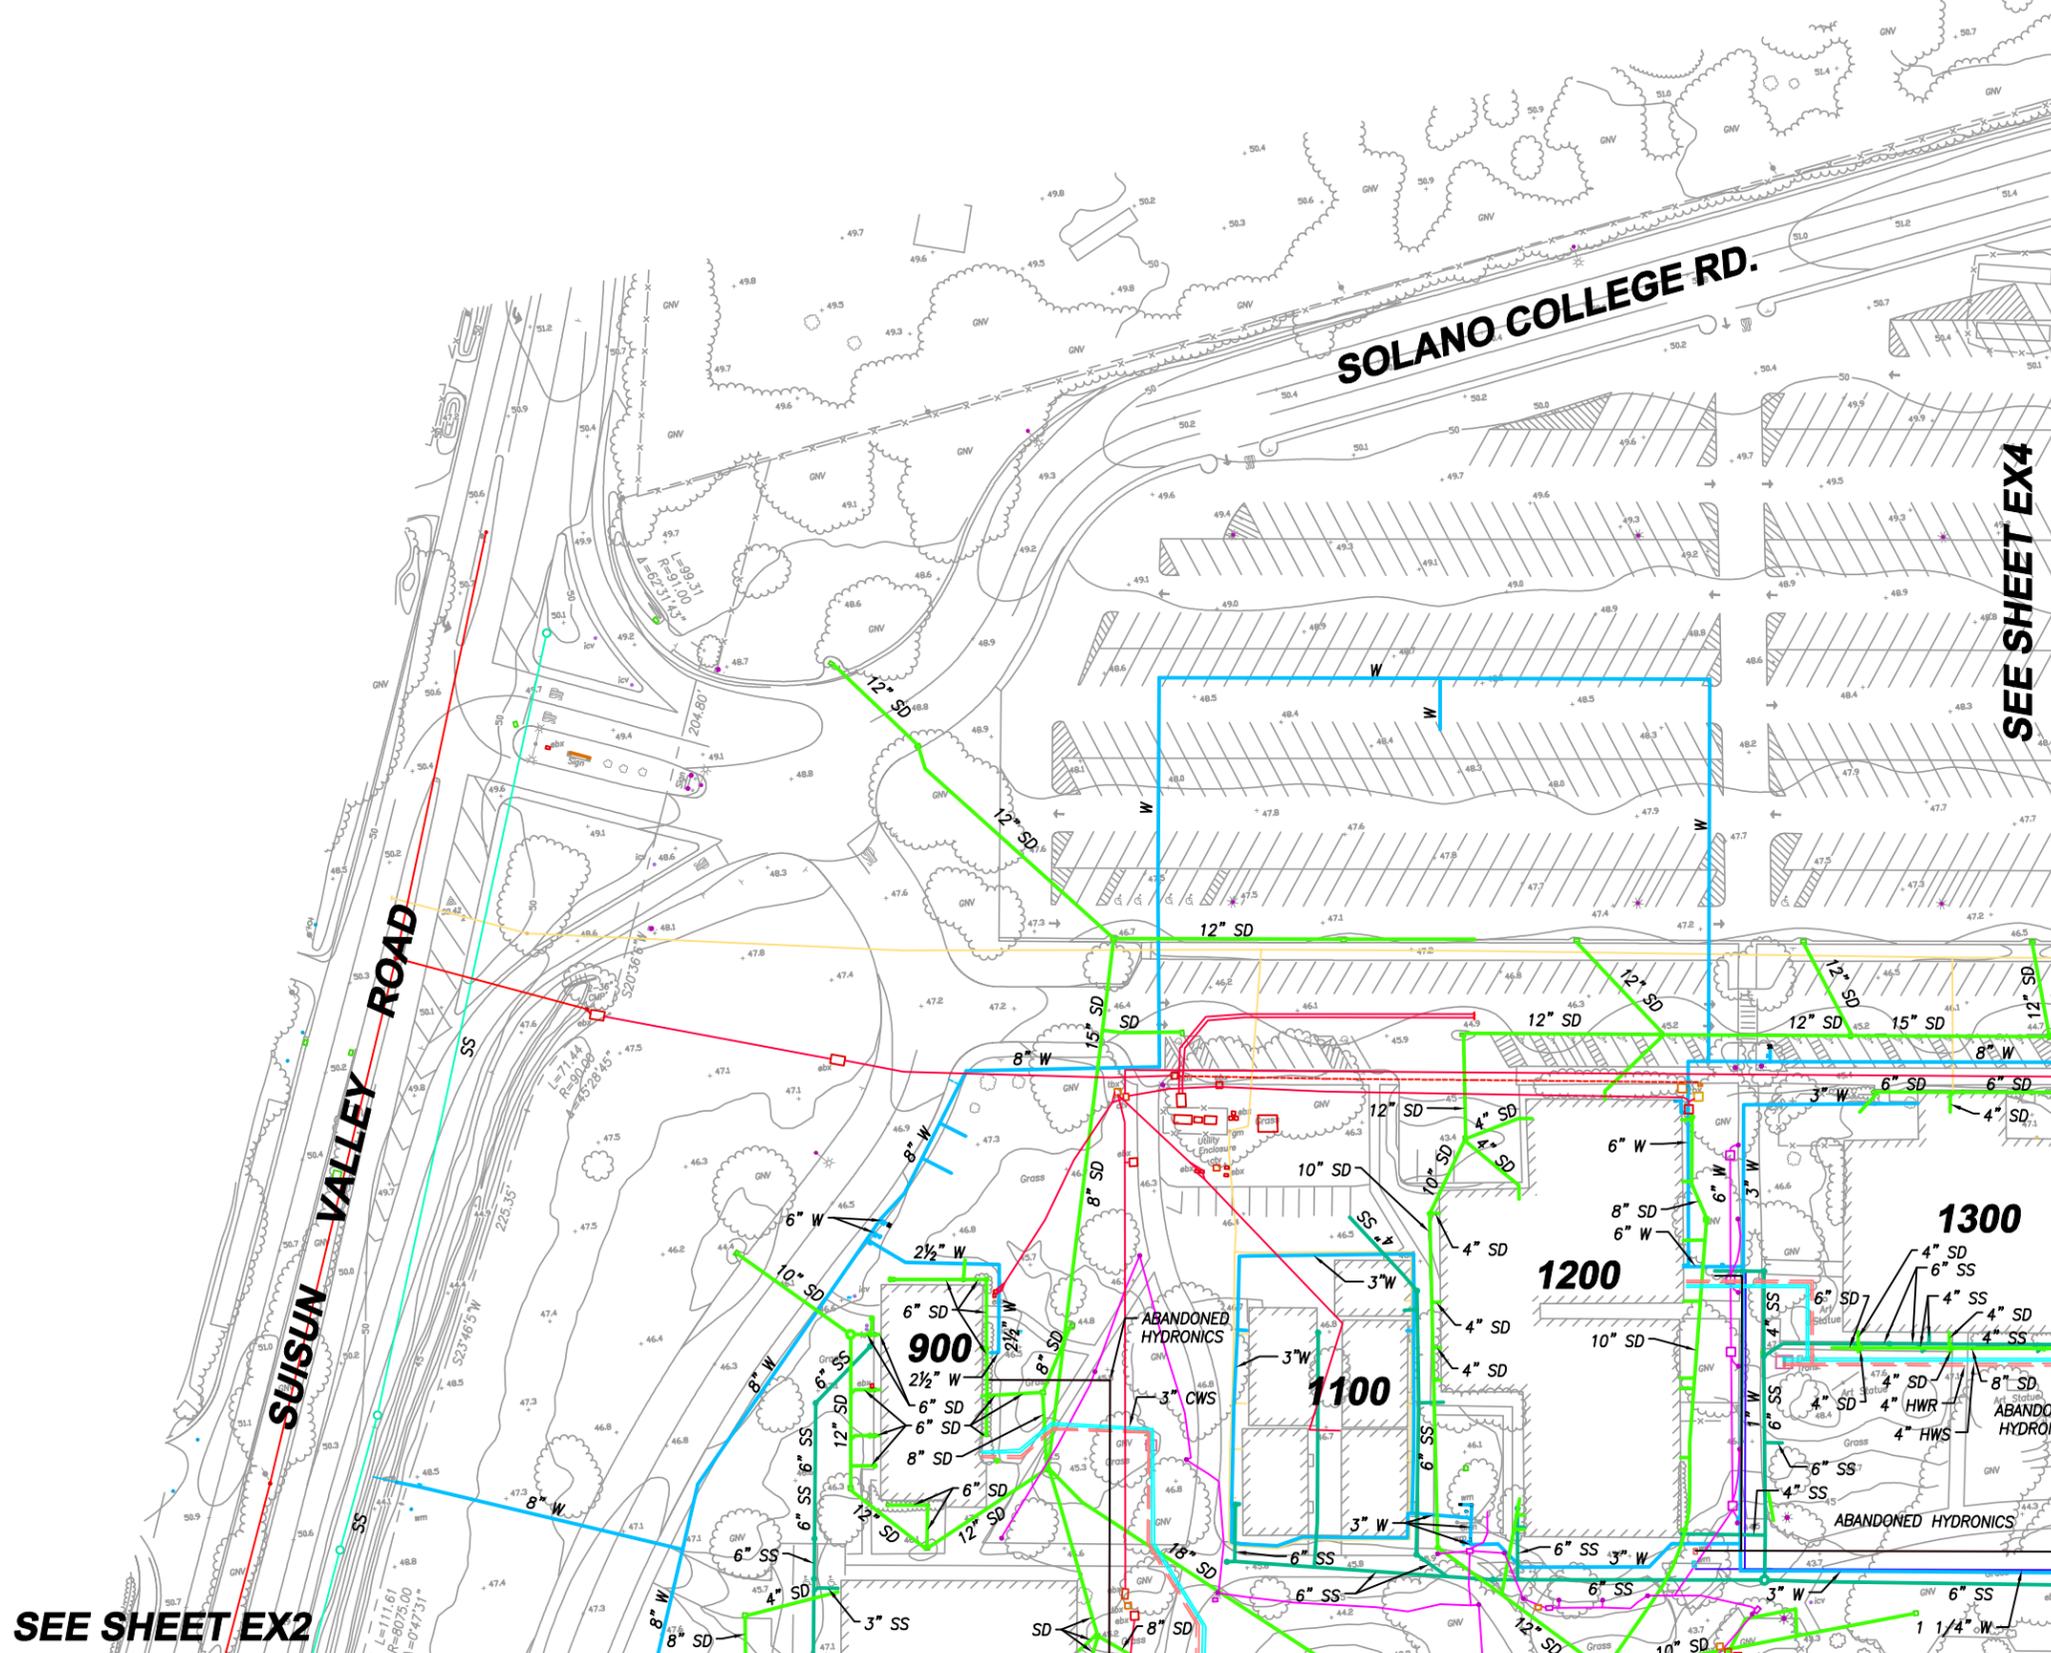
EX1

EXISTING UTILITIES

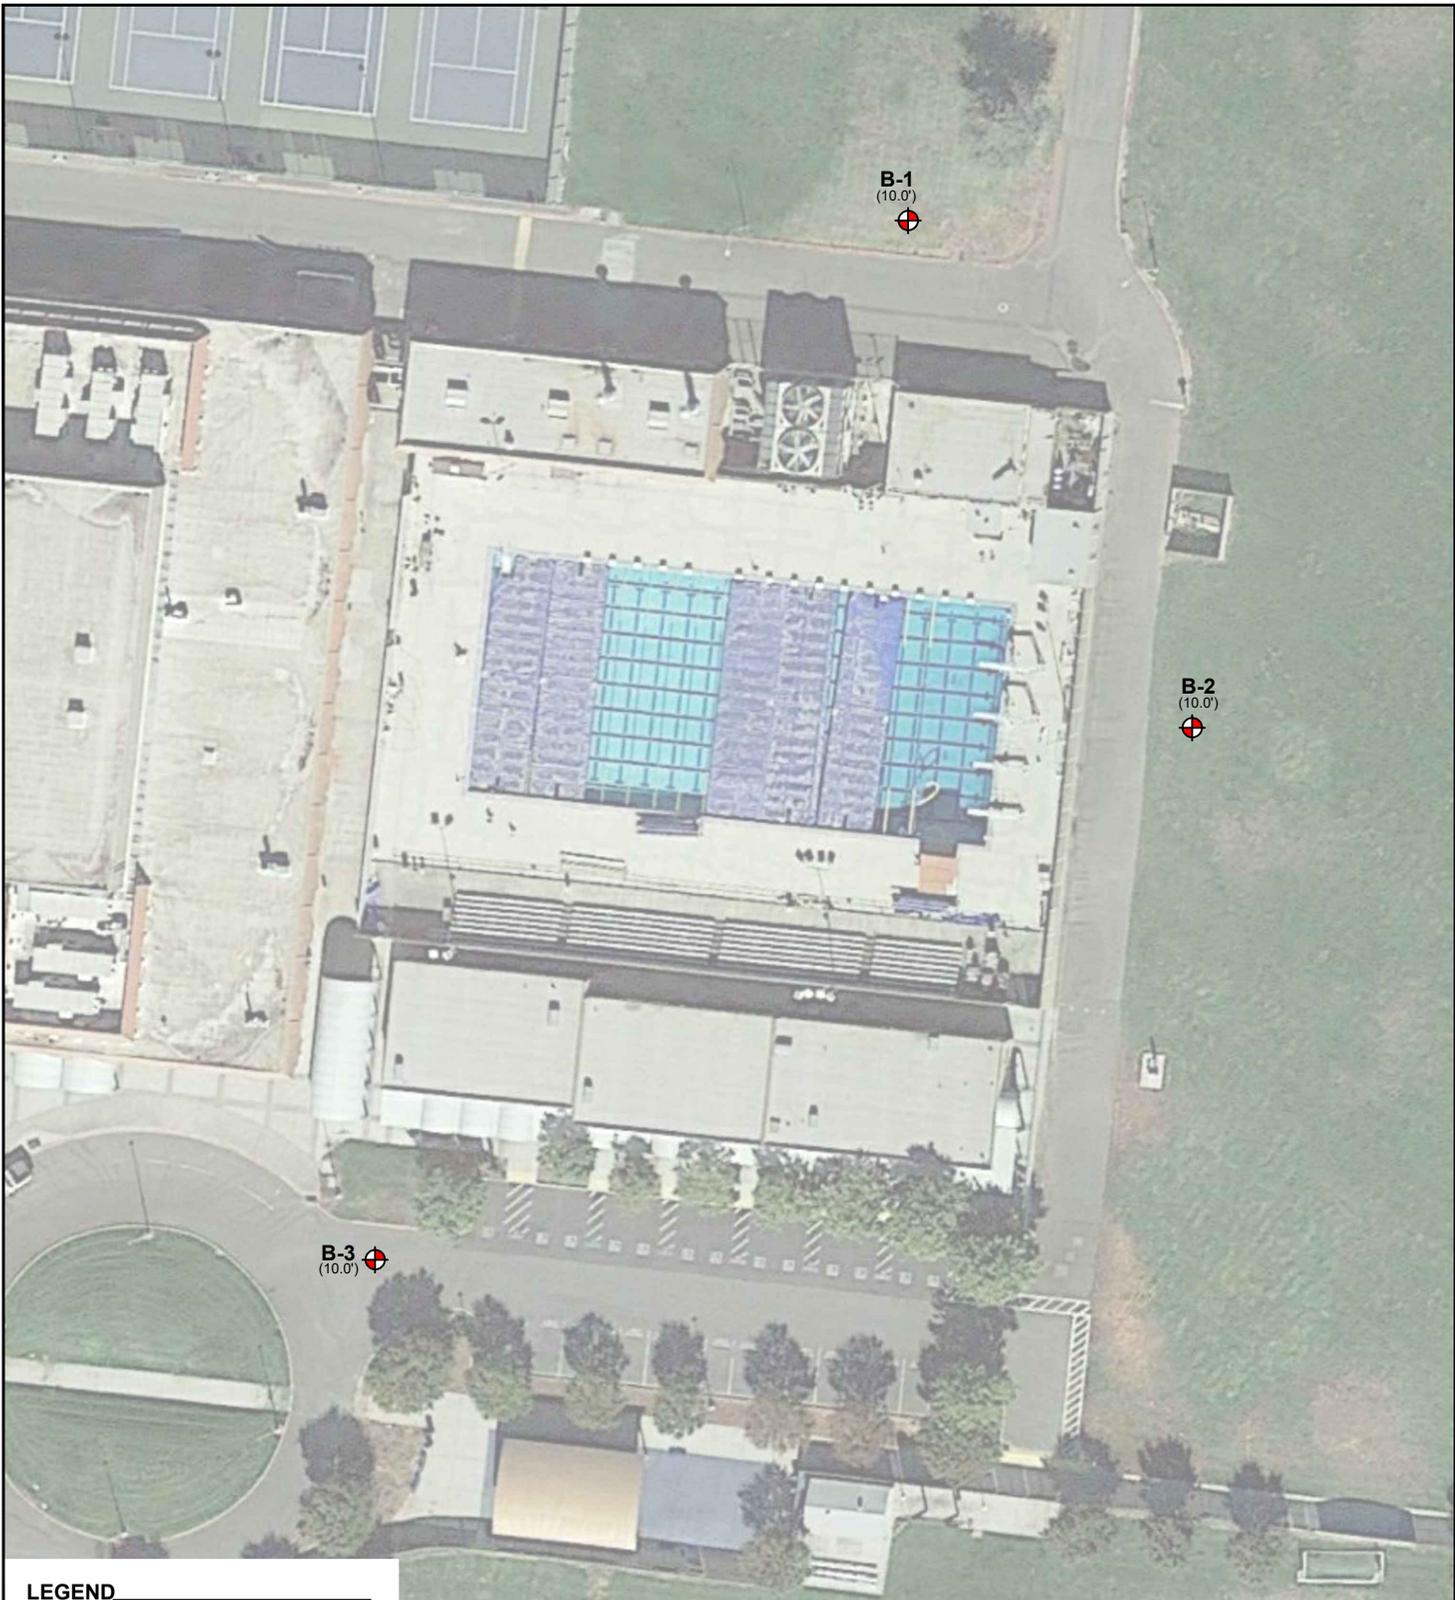
FIGURE 2

B-1 (10.0')

collected bulk and relatively undisturbed soil samples from the borings. The samples were transported to our geotechnical laboratory for testing. The borings were backfilled with grout immediately after excavation. The boring logs are presented in Appendix A. Locations of the geotechnical borings are presented in Figure 2.

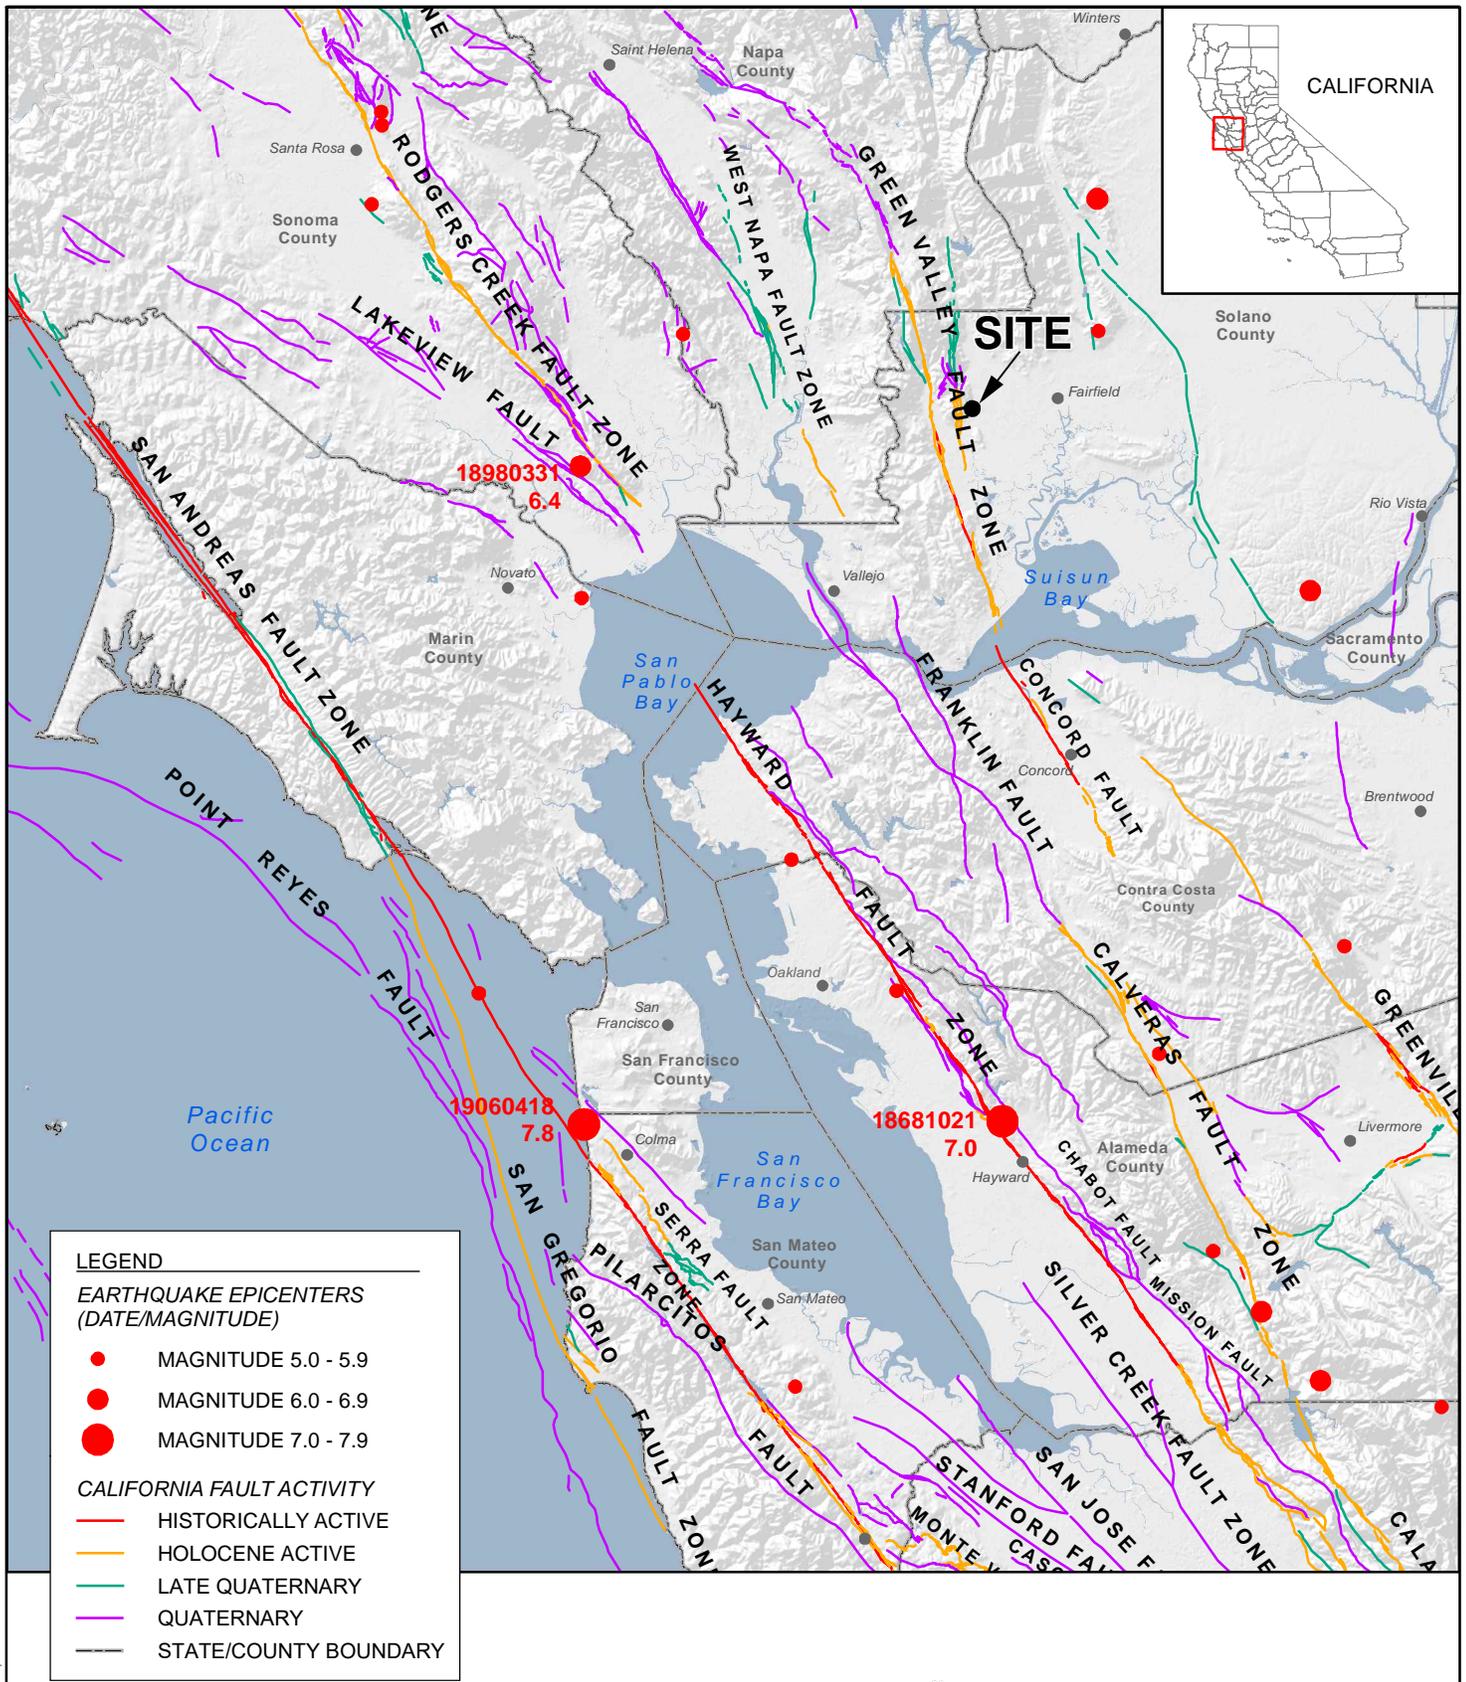
FAULT LOCATIONS AND EARTHQUAKE EPICENTERS

SOLANO COMMUNITY COLLEGE POOL DECK
4000 SUISUN VALLEY ROAD, FAIRFIELD, CALIFORNIA

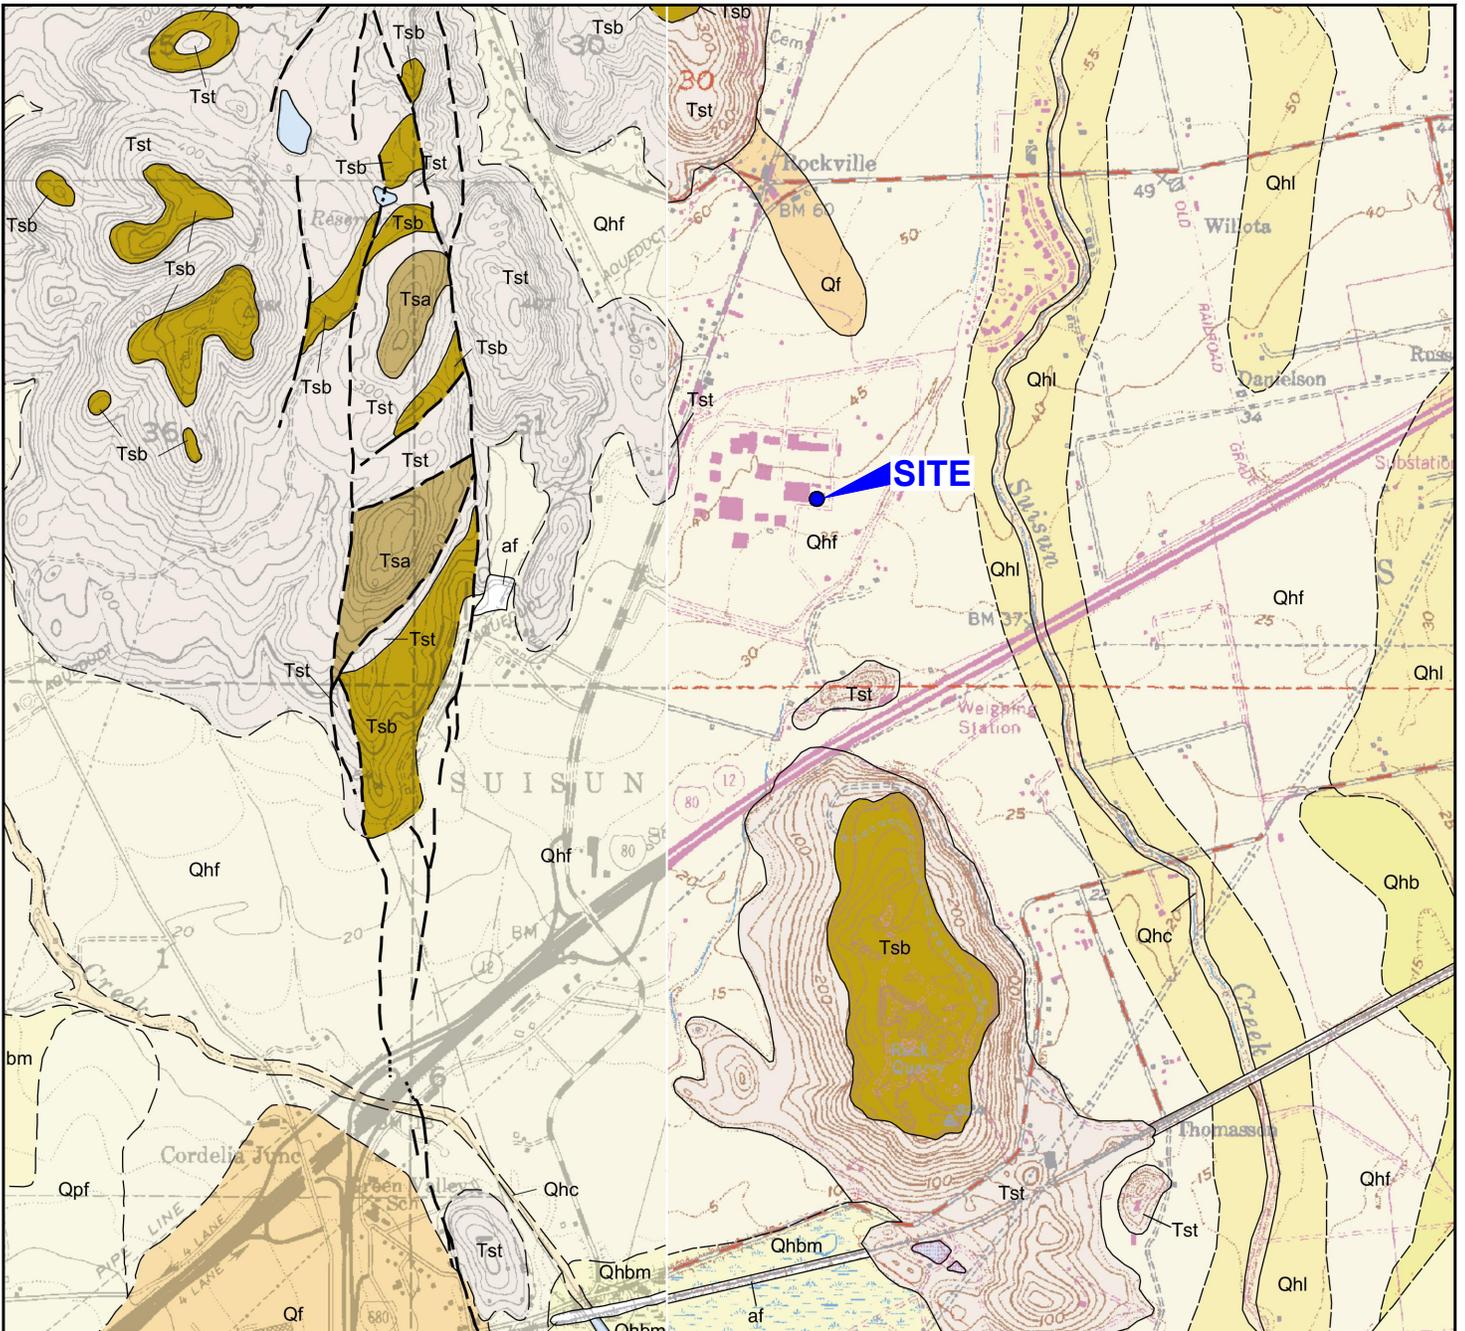
FIGURE 4

af ARTIFICIAL FILL (HOLOCENE)	Qhf ALLUVIAL FAN DEPOSITS (HOLOCENE)	Tst ASH-FLOW TUFF (PLIOCENE)	GEOLOGIC CONTACT
Qhbm BAY MUD (HOLOCENE)	Qhl FAN LEVEE DEPOSITS (HOLOCENE)	Tsa ANDESITE (PLIOCENE)	STRIKE AND DIP OF BEDDING
Qhb BASIN DEPOSITS (HOLOCENE)	Qf ALLUVIAL FAN DEPOSITS (HOLOCENE/PLEISTOCENE)	Tsb BASALT (PLIOCENE)	THRUST FAULT
Qhc MODERN STREAM CHANNEL DEPOSITS (HOLOCENE)	Qpf ALLUVIAL FAN DEPOSITS (PLEISTOCENE)		FAULT

Review of available geologic maps and reports indicates that the project area is underlain by Holocene age alluvial fan deposits (Figure 4). According to regional geologic studies by Bezore et al. (1998a and 1998b) and Graymer et al. (2002), the Holocene age alluvial fan deposits typically consist of silt and clay interbedded with layers of sand and gravel. The alluvial deposits are derived from the bedrock formations exposed in the nearby foothills and local mountains. The local bedrock formations are part of the Pliocene age Sonoma Volcanics and consist of layers of ash flow tuff, andesite, and basalt.

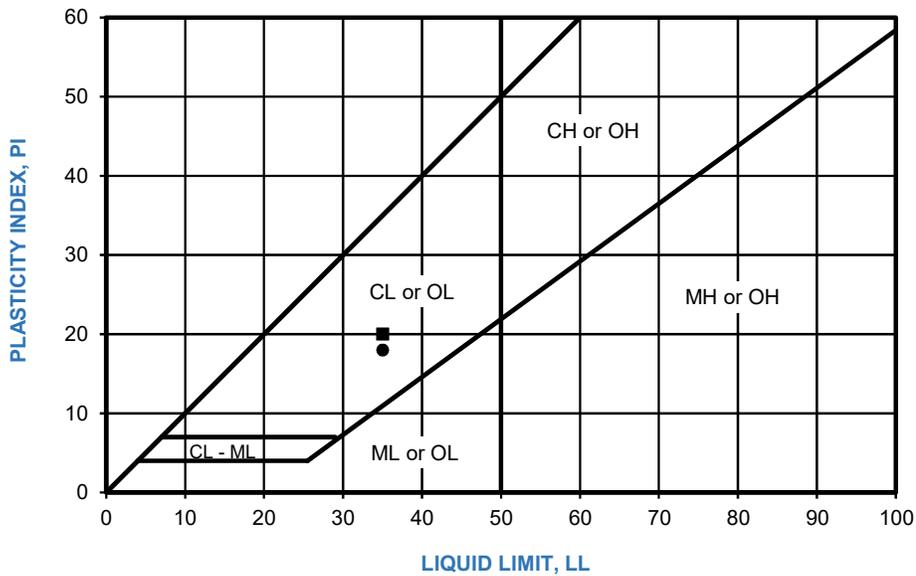
FIGURE B-1

SYMBOL	LOCATION	DEPTH (ft)	LIQUID LIMIT	PLASTIC LIMIT	PLASTICITY INDEX	USCS CLASSIFICATION (Fraction Finer Than No. 40 Sieve)	USCS
●	B-1	5.5-6.0	35	17	18	CL	CL
■	B-2	3.0-3.5	35	15	20	CL	CL

PERFORMED IN ACCORDANCE WITH ASTM D 4318
